**NIST NCSTAR 1-3 (Draft)**

**Federal Building and Fire Safety Investigation of the  
World Trade Center Disaster**

# **Mechanical and Metallurgical Analysis of Structural Steel (Draft)**

September 2005

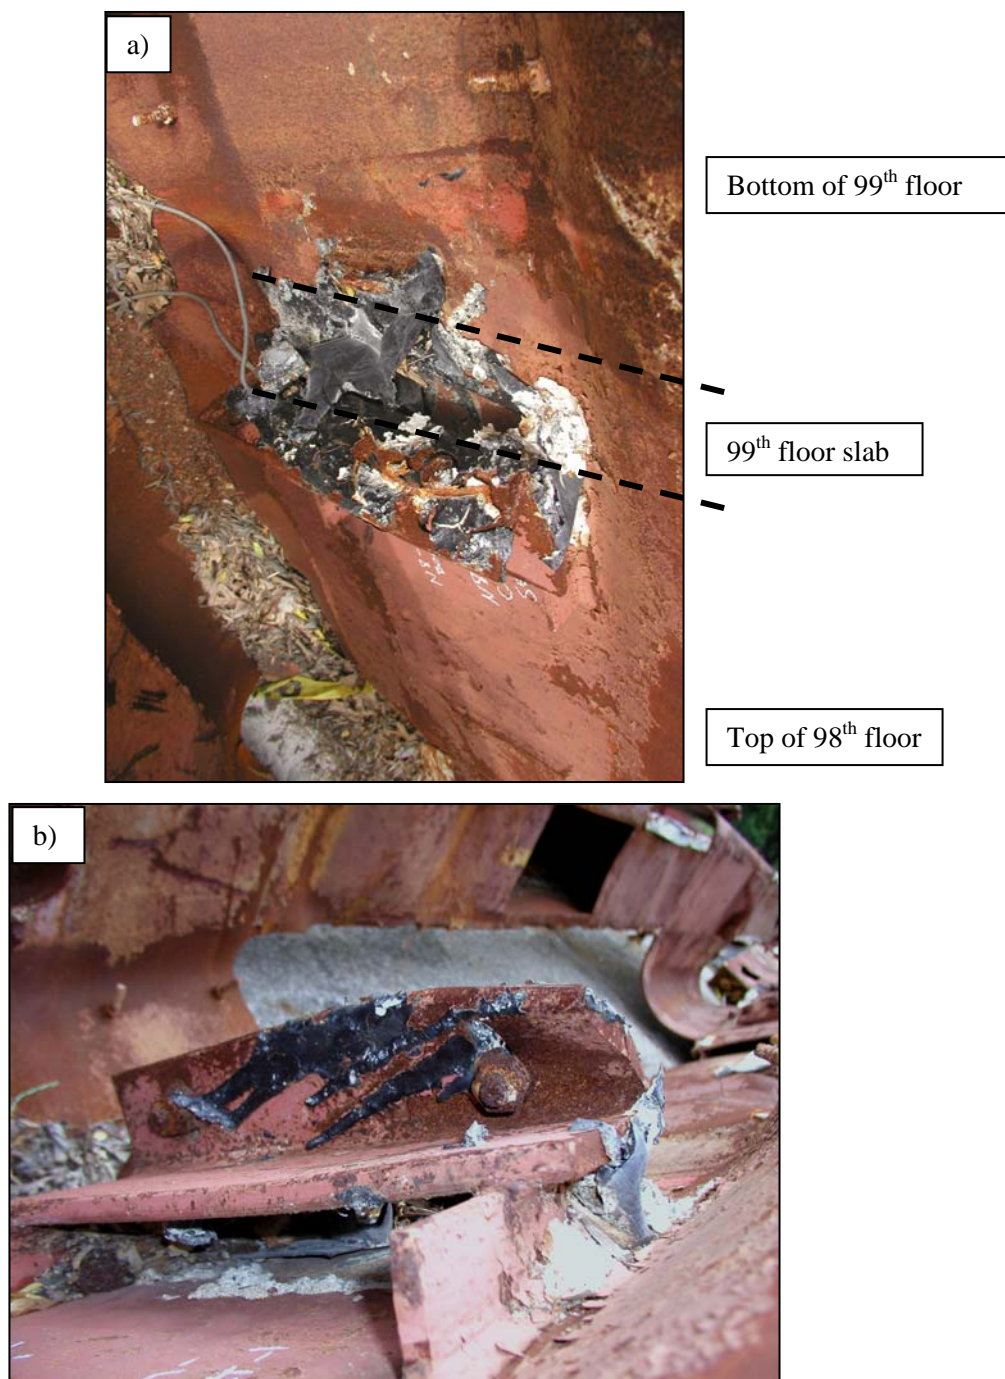
3. Panel N-8, WTC 1, column 143, seat and standoff plates of the 99th floor. This seat (Fig. 6–38) was exposed to fire for a minimum of 18 cumulative minutes before collapse. Mud cracking was not observed on the spandrel plate to which the seat was welded.

**Figure 6–38. Truss seat of the 99th floor on column 143 of sample N-8 (A142: 97-100). a) Top view showing the re-solidified black plastic with embedded papers, most likely a binder of some type and b) bottom view showing the drip pattern. It was unknown when the high-temperature excursion may have occurred.**

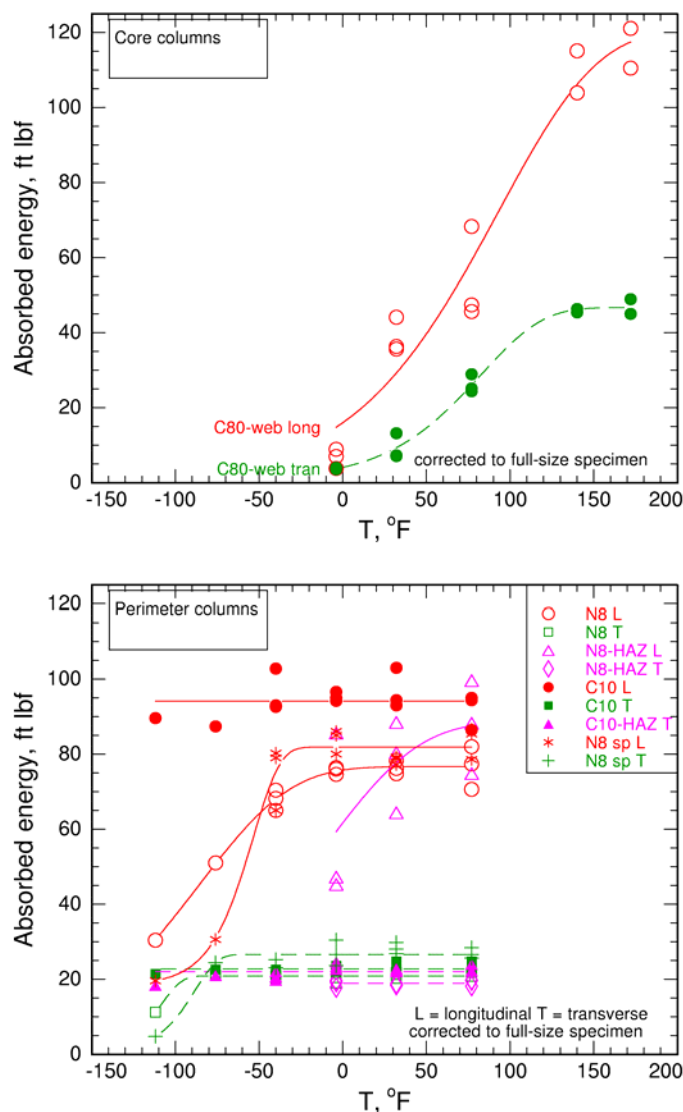
Figure 7–7 summarizes the results of Charpy tests on perimeter and core column steels. All the perimeter column steels have large upper shelf energies and transition temperatures well below 0 °F. The transition temperatures of the web of the wide-flange specimen, Fig. 7–7, and the truss rods and angles, not shown, are near room temperature, but they still possess adequate toughness for use as structural steels. The transition temperatures of the truss seat steels are above room temperature, and the absorbed energy of the steels even at room temperature is low, indicating a propensity for low-energy failure.

**Figure 7–7. Summary data for Charpy tests. Lower figure: perimeter column steels; upper figure: core column steels.**

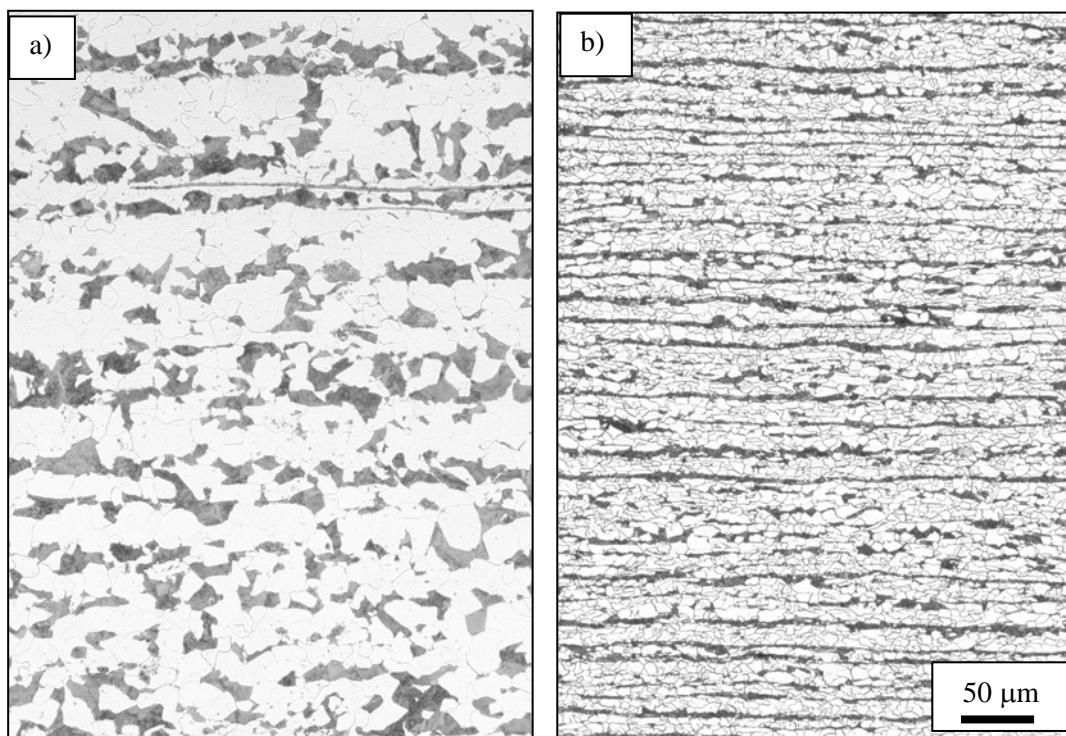
For the exterior panel sections, two different microstructural types were observed. Flange, web, and spandrel plates with specified minimum yield strengths less than 70 ksi were ferrite-pearlite (Fig. 8–1). Additionally, inner webs with  $F_y$  of 70 ksi and 75 ksi were ferrite-pearlite. For the Yawata produced plates (flange, outer web, and spandrel), this type of microstructure was expected given the measured plate thickness and specified minimum yield strength (refer to NIST NCSTAR 1-3A). Plates with  $F_y$  less than 70 ksi were typically hot rolled unless the following sizes were exceeded for a given  $F_y$ : 0.5" for 65 ksi, 1.25" for 60 ksi, and 1.5" for 55 ksi. For these specified plates, as well as those with minimum yield strengths equal to or greater than 70 ksi, “quenched-and-tempered” microstructures were observed (Fig. 8–2).

**Figure 8–1. Microstructure of ferritic-pearlitic WTC perimeter column flange plate steels. a)  $F_y = 45$  ksi (unidentified perimeter column with “45” flange stamping) and b)  $F_y = 60$  ksi (WTC 1, column 126, 97th floor).**

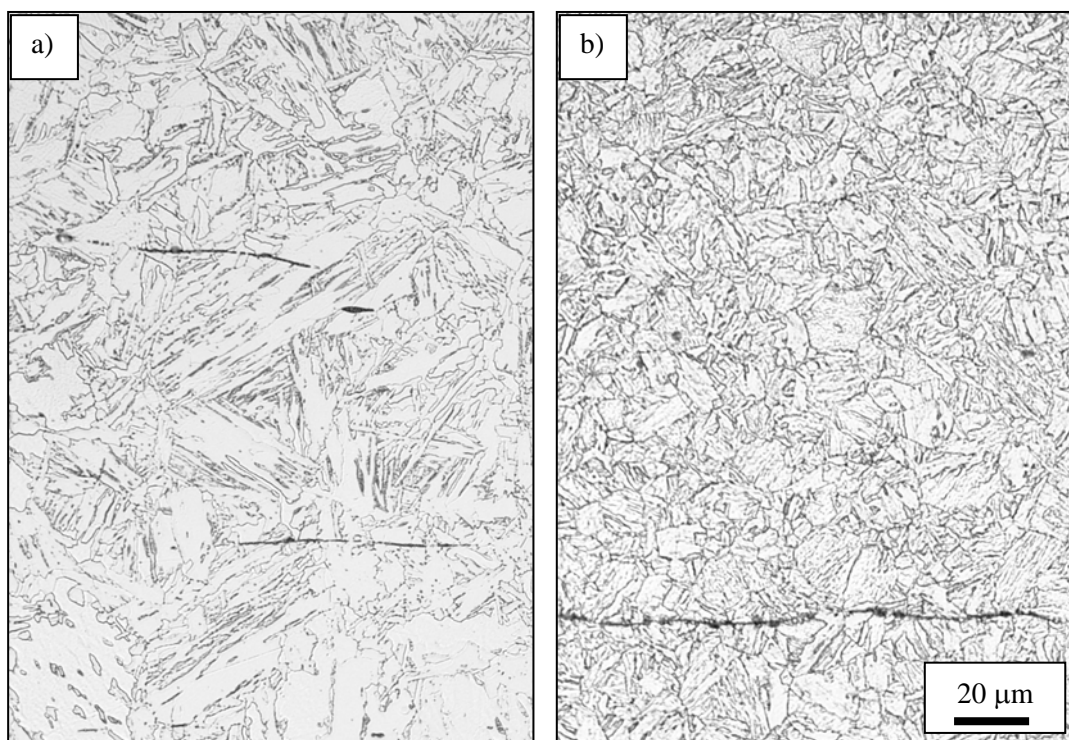
Microstructure varied within each of the two structure types, depending on product type, gauge, and strength level. Ferrite-pearlite steels had variations in ferrite grain size, ferrite grain shape, pearlite lamellar spacing, and banding of microstructural constituents with a change in specified  $F_y$  and gauge of the plate. Examples of these microstructures are shown in Fig. 8–1. Similarly, the quenched and tempered steels had variations with  $F_y$ . Plates with  $F_y = 70$  ksi had a coarse Widmanstätten morphology of ferrite with coarse cementite precipitates while the higher strength plates had what appeared to be a tempered martensitic structure, as shown in Fig. 8–2.

**Figure 8–2. Examples of “quenched and tempered” WTC perimeter column flange steel. a)  $F_y = 70$  ksi (WTC 1, column 224, 94th floor) and b)  $F_y = 80$  ksi (WTC 1, column 207, 89th floor).**

For each of the designated minimum yield strengths, the type of structures observed was expected for steels of that era. While the microstructural features may have varied from plate to plate, there was no indication that the practices followed to produce the plates were improper.
