**NIST Special Publication 1164**

# **Preliminary Reconnaissance of the May 20, 2013, Newcastle-Moore Tornado in Oklahoma**

Erica D. Kuligowski  
Long T. Phan  
Marc L. Levitan  
*Engineering Laboratory  
National Institute of Standards and Technology*

December 2013

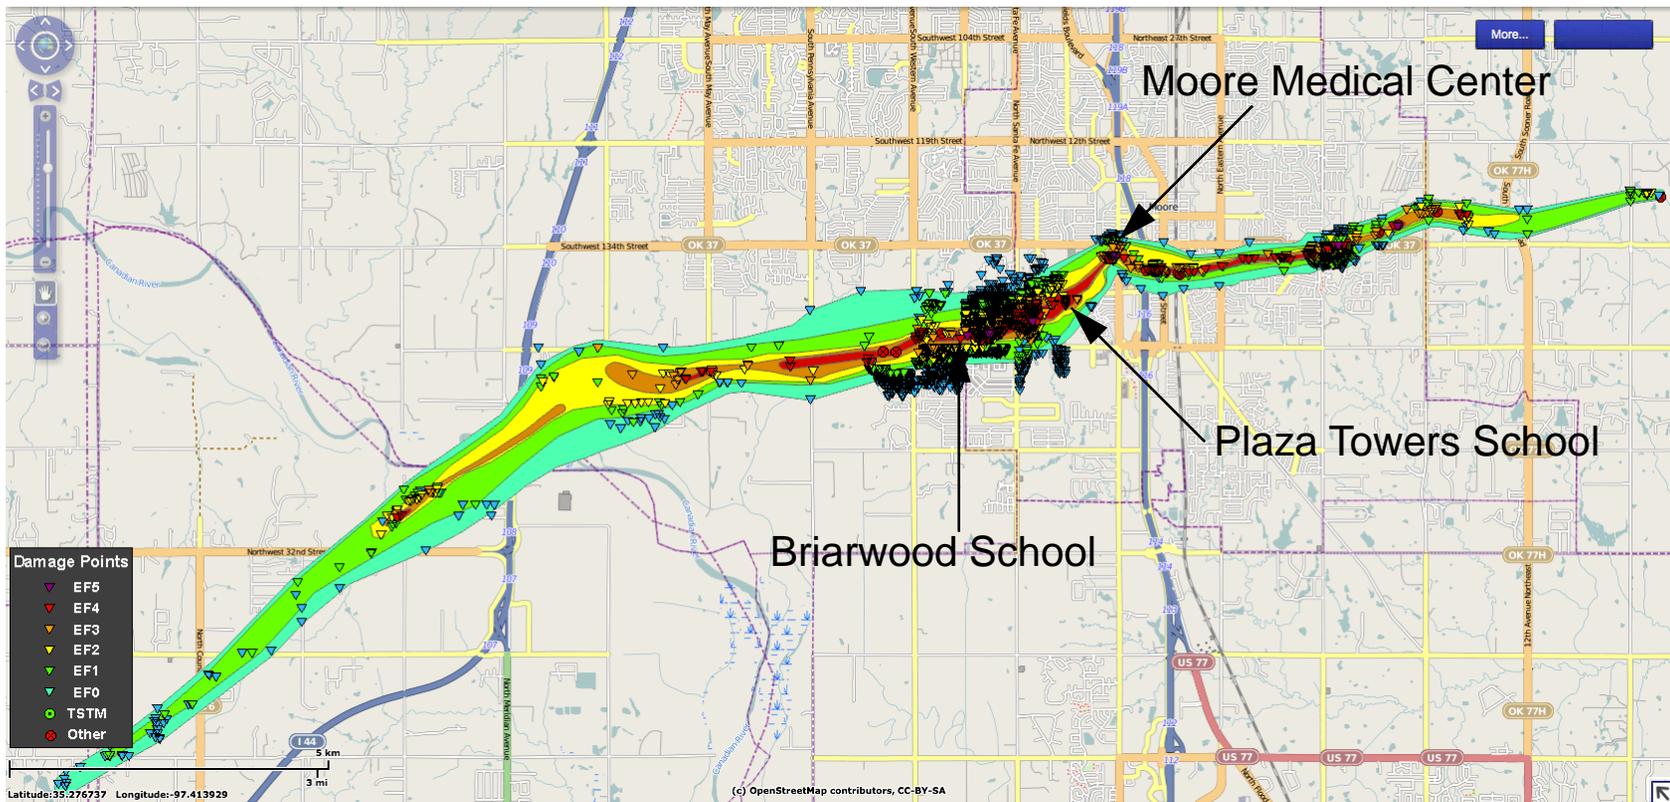
Figure 2-4. Tornado damage path map showing point estimates of EF damage at specific locations (triangles) and swaths for EF-0 (turquoise), EF-1 (green), EF-2 (yellow), EF-3 (brown), EF-4 (red) and EF-5 (purple) intensity damage (data source NOAA/NWS). The locations where damage was evaluated represents only a small percentage of the number of buildings damaged or destroyed by the tornado.

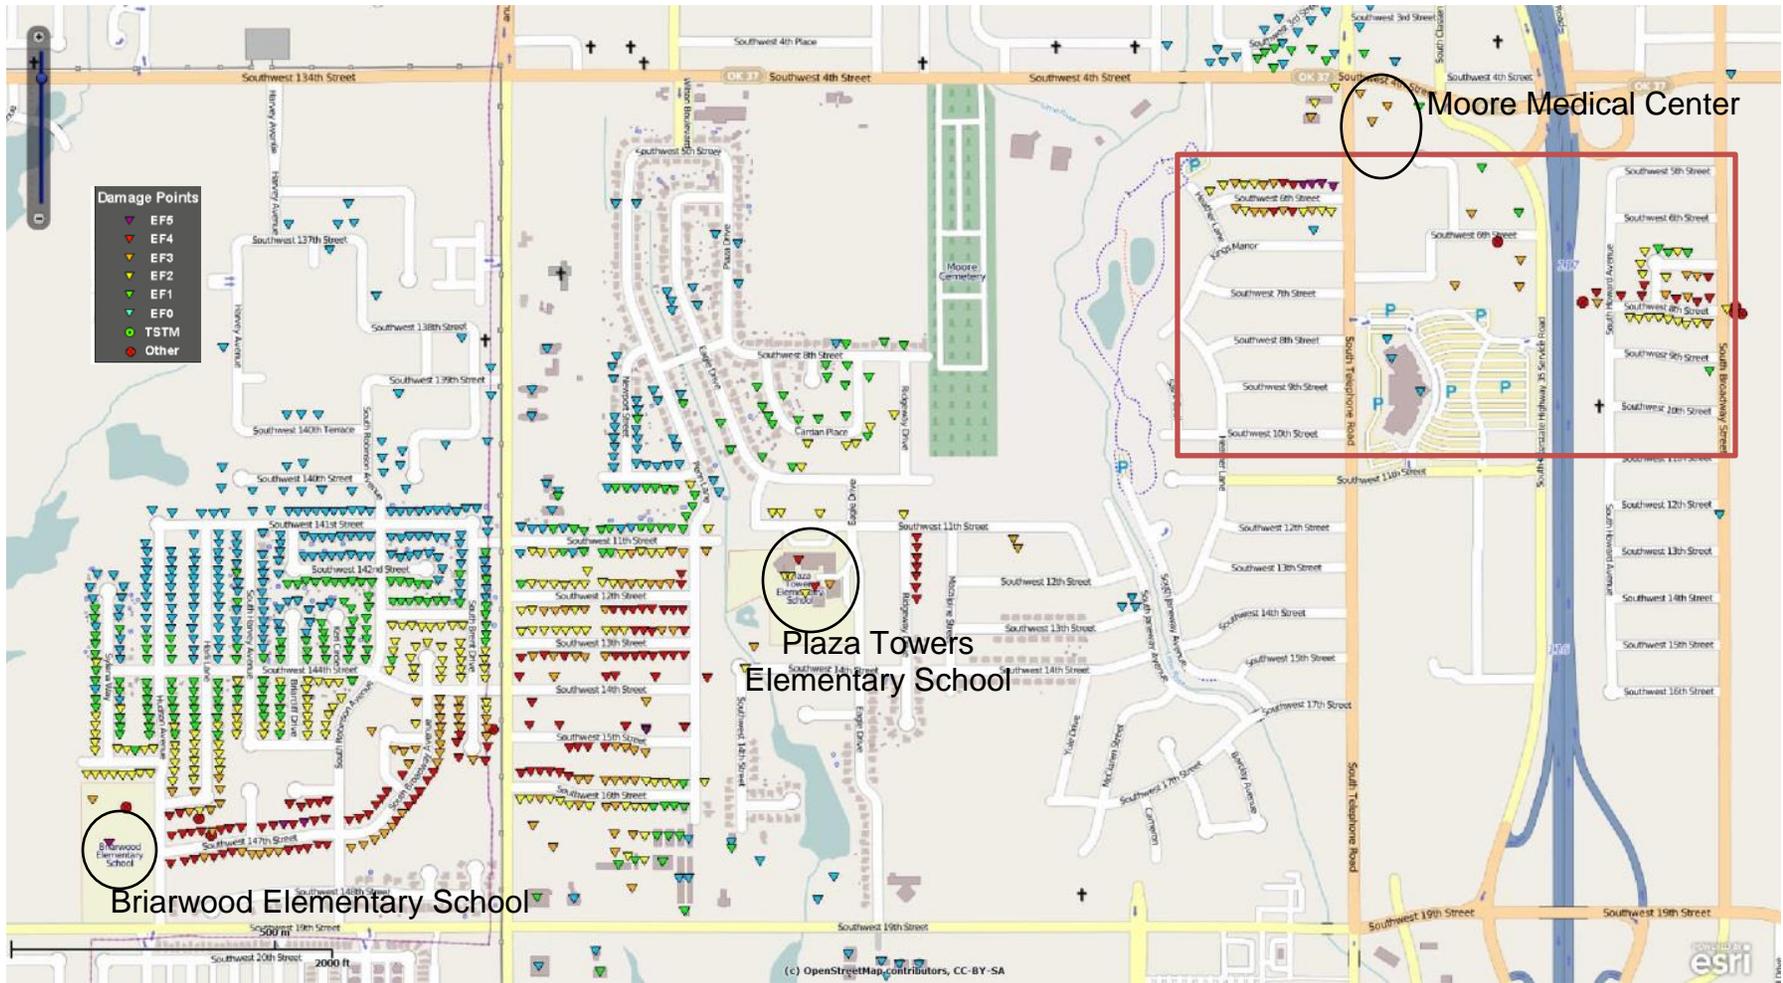
Figure 2-7. EF-rated damage by NWS west of Interstate 35 in the vicinity of Briarwood and Plaza Tower Elementary Schools and the Moore Medical Center. The triangles indicate locations where damage was assessed and the triangle color indicates the EF number assigned to each assessment. The red rectangle shows the approximate field of view of the aerial photo in Figure 2-6.

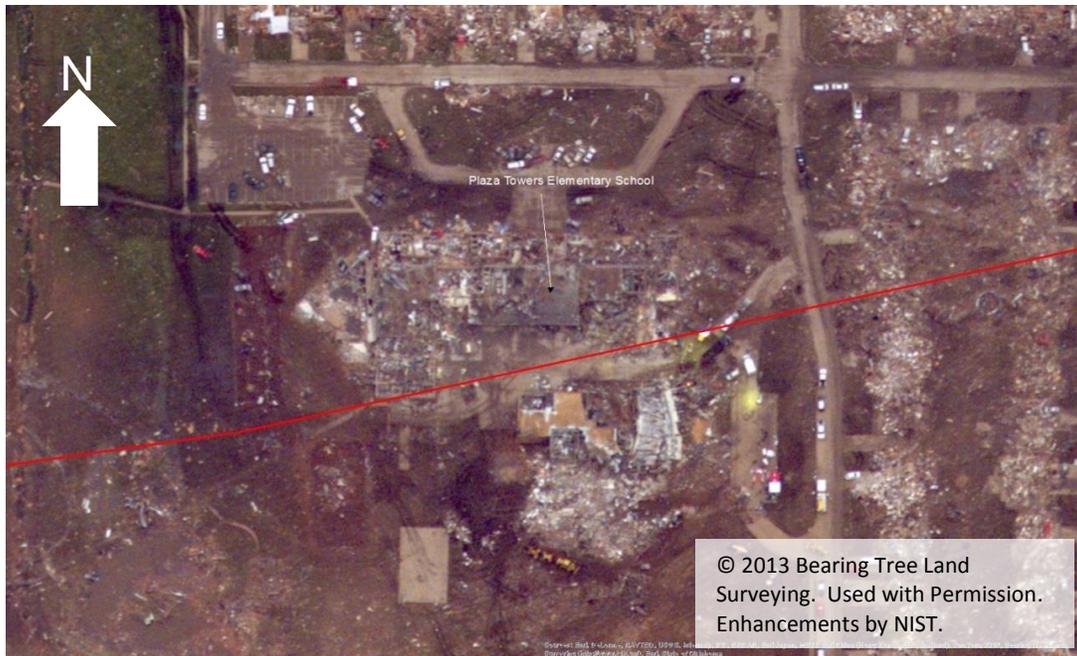
The buildings of Plaza Towers Elementary School sustained significant structural damage due to strong wind and debris impact loadings. Figures 4-4 and 4-5 show aerial views of Plaza Towers Elementary School shortly after the tornado hit. Following is a summary of the damage observed at this facility and related fatalities and injuries.

Figure 4-4. Aerial photograph of Plaza Towers Elementary School and proximity to estimated center of tornado damage path.

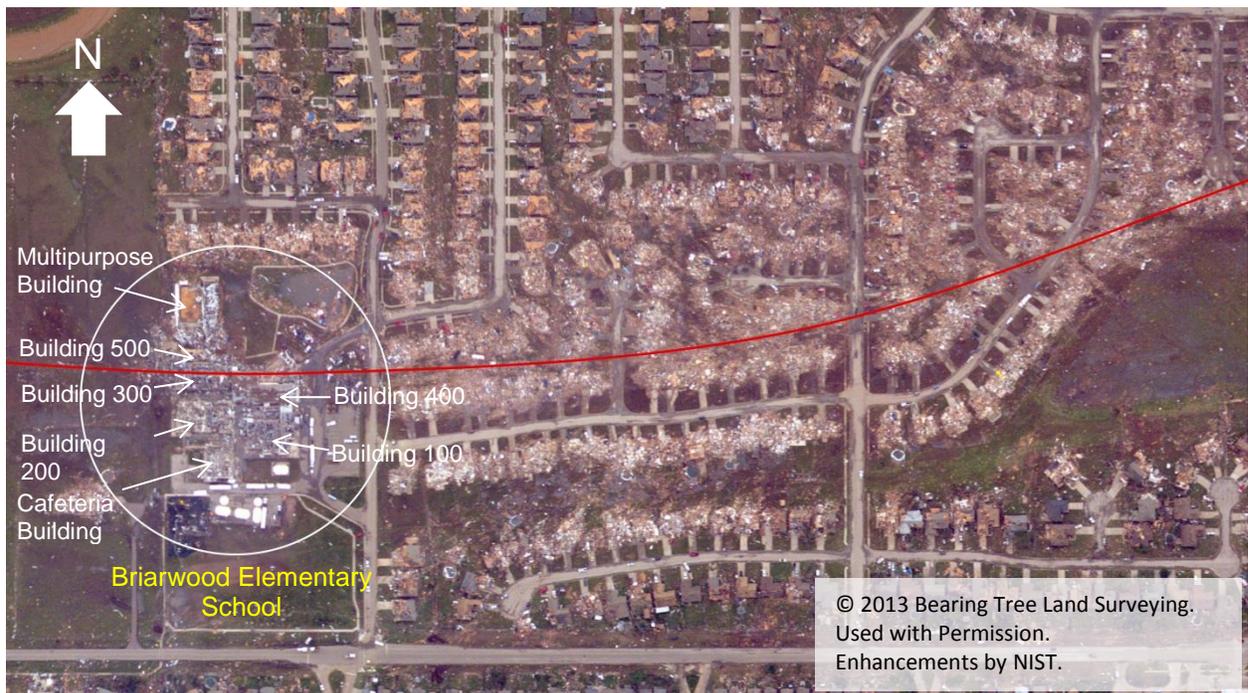
Figure 4- 13. Aerial photograph of Briarwood Elementary School and proximity to estimated center of tornado damage path (red line).

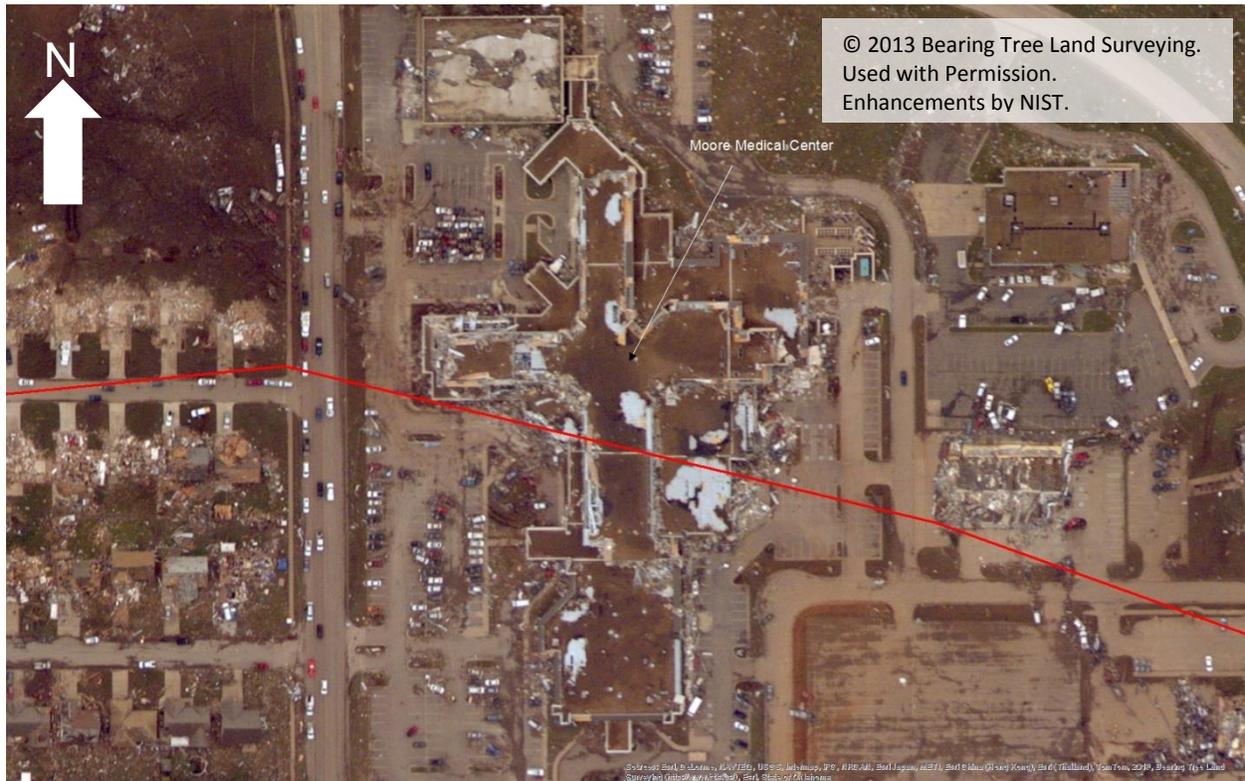
The estimated centerline of the tornado damage path passed close to the center of the facility (Figure 4- 23). The damage across the entirety of the exterior of the Moore Medical Center is shown in Figs. 4-24 through Figure 4-26. The figures show severe damage to much of the interior of the hospital and the medical office buildings. Similar to the two elementary schools discussed earlier in the report, the Moore Medical Center was also subjected to both wind and wind-borne debris impact loading; however, the structural damage to the Medical Center was minimal compared to the schools. Debris hazards included automobiles (and automobile parts) tossed against, into, and onto the building, and a large steel trash dumpster that landed on top of the second story of the west nursing wing of the hospital, damaging the roof deck and supporting bar joists (Figure 4-28).

Figure 4-23. Aerial photograph of Moore Medical Center shortly after the tornado struck, showing estimated centerline of the tornado damage path (in red).
