**HYDROGEN RELEASE AND
COMBUSTION MEASUREMENTS IN A
FULL SCALE GARAGE**

Final Test Report

Contract SB134109SE0612
SwRI® Project No. 01.15071

SOUTHWEST RESEARCH INSTITUTE®
6220 Culebra Road • P.O. Drawer 28510
San Antonio, Texas 78228-0510

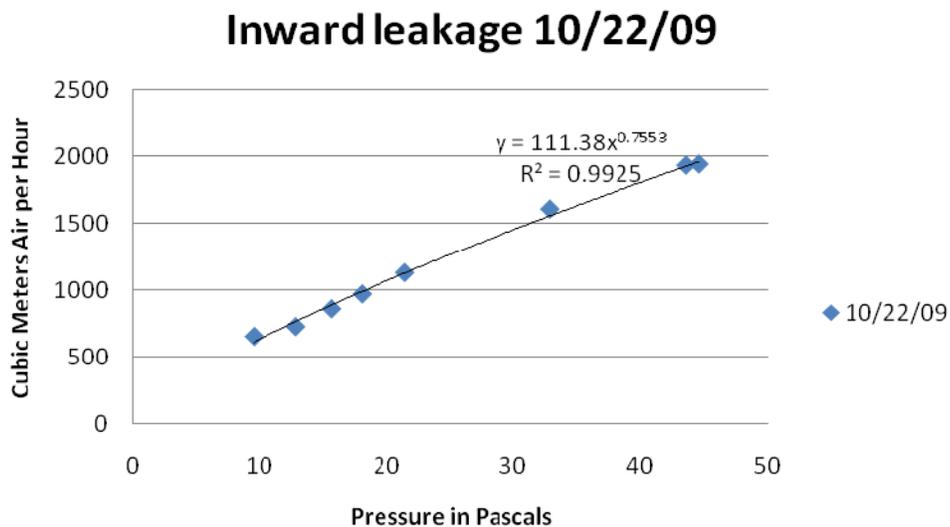
Figure 1. Inward Leakage Calculation for Test Conducted on 10/22/09.

A model E-3 Blower Door test system manufactured by INFILTEC was used to measure the inward leakage of the structure prior to initiating testing each day. Working in negative pressure mode the pressure was measured in pascals (Pa) and flow in m³ per hour. Pressure and flow were measured at several fan settings and plotted to create a best fit plot fitting the exponential formula $q = Cp^n$ where q is the flow rate, C is the flow coefficient, p = pressure in Pa, and n = flow exponent for the building. The result was used to calculate the inward leakage rate at 4 Pa. The target inward leakage rate was 3 to 10 air changes per hour (ACH)₄ for the internal volume of 113 m³ for the garage. All of the inward leakage data is present in the electronic data in a single spreadsheet organized by date of testing. In Figure 1, a total of eight data points were collected and the best exponential fit was calculated using Excel™. In this case the result was $C = 111$ and $n = 0.755$, giving an inward leakage rate of 2.8 (ACH)₄.

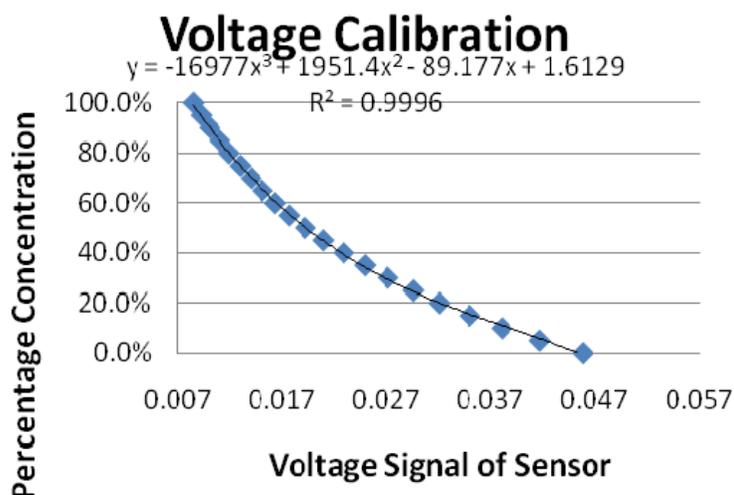
Figure 2. Hydrogen Sensor Calibration Curve with Best Fit Line Formula.

Thermal conductivity sensors were used to measure real-time hydrogen concentrations along a vertical line for locations above the floor separated by 0.38-m intervals. Model TCG-3880 sensors manufactured by Xensor Integration were installed and calibrated before each test. A calibration method developed by Dr. William Pitts at NIST, based on measured thermal conductivities for hydrogen/nitrogen mixtures, was used to create individual calibration curves for each sensor using measured sensor response to 0 % and 100 % hydrogen. The approach was validated by demonstrating that it correctly predicted sensor response to a 4.0 % calibration gas standard. The sample calibration shown in Figure 2 includes the third order polynomial best fit line for the hydrogen sensor. The constants shown vary from sensor to sensor. Plots of hydrogen concentration were prepared by converting the mV signals from the thermal conductivity detectors to percentage concentration of hydrogen using the formula shown in Figure 2. The conversion of the data resulted in average biases of -0.9 % at zero concentration. The cause of the negative biases is still being investigated.

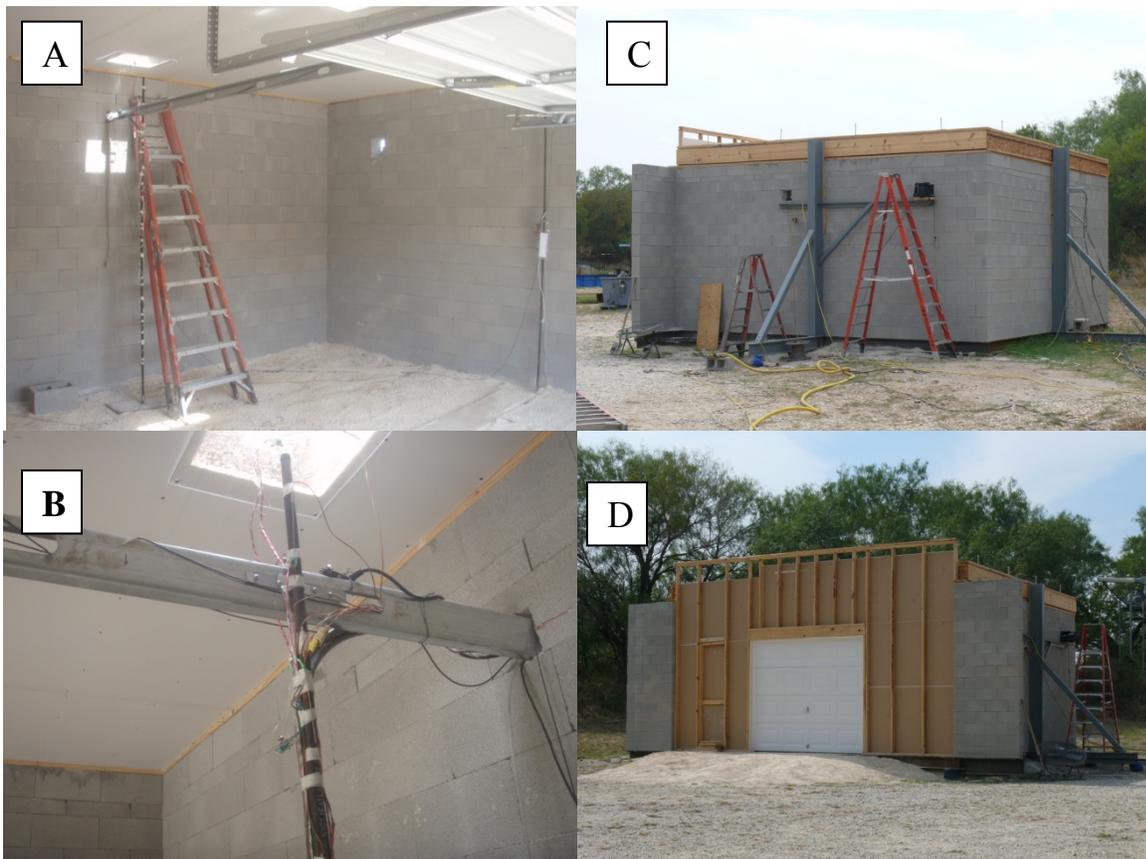
Figure 4A–D. Inside and Outside Views of Test Garage.

A simulated garage structure was constructed on the Ballistics Range at SwRI in San Antonio, TX, to determine the effects of a hydrogen deflagration scenario. The garage was fabricated with inner dimensions of 6.1 m × 6.1 m × 3.05 m. Three of the walls (rear and two sides) were constructed of stacked, interlaced mortar-filled concrete block. Rebar reinforcing, 19 mm, was welded to the I-beam foundation frame every 0.81 m and passed upward through the blocks to the top of the wall. The original structure had I-beam buttress supports located in the middle of each wall for additional strength as well as wing walls on the front of the structure. Subsequent to the 28.8 % test, I-beam supports were added to the corners for additional strength. The front wall was constructed from 3.7 m long pine 2 × 4 framing beams at 0.60-m intervals with 1.3-cm (½-in.) thick gypsum board inner surfaces. The bottom of the front wall was constructed of two pieces of 1.8-m long pine 2 × 4 framing that rested on but were not attached to the I-beam foundation. The front wall was attached to the 2 × 6 cap beams of the side walls at one point on both sidewalls using 3 in wood screws. An un-insulated metal panel 2.1-m × 2.4-m garage door was installed in the center of the front wall. The roof of the structure was constructed with 30.5-cm (12-in.) high engineered wooden I-beams constructed of oriented strand board (OSB) and 2.5-cm plywood spaced every 0.46 m covered with 1.6-cm (5⁄8-in.) thick plywood. The roof was attached to the block construction by 25 mm all thread rods with 0.45 m lengths exposed above the roof decking. Each of the all thread rods was capped with a nut and washer. The all thread allowed for some pressure release by allowing the ceiling to travel straight upward in a controlled manner, thus creating an opening between the rear and side walls and the roof. Once the pressure was released, the roof would settle back down on the walls. The inside of the ceiling was lined with 1.3-cm (½-in.) gypsum board and all seams were sealed with latex caulking and/or duct tape. Figures 4A–D show inside and outside views of the test garage. Two 0.2-m × 0.2-m square windows at a height above the floor of 2.59 m were installed in the right side wall to facilitate the videography of testing, as shown in Figure 4C. A (0.3-m × 0.3-m) square window was also installed in the ceiling above the sensor array and ignition point to allow for light to increase visibility as shown in Figure 4B.

Figure 4B shows a portion of the vertical and horizontal sensor arrays and the ignition point. This photo shows the spark ignition system prior to its replacement with electronic matches. The vertical sensor array is mounted on a 0.25-m diameter pipe attached to a flat metal plate acting as a stand. The horizontal sensor array is mounted on a hollow steel (2 × 4) construction stud that was 5.5 m long. The stud passed through an opening in the rear concrete wall and was suspended from the ceiling at the front with a piece of all thread that penetrated the roof. The horizontal sensor array was along a nearly constant height of 2.59 m above the floor and extended from near the back wall to just short of the garage door, bisecting the garage.

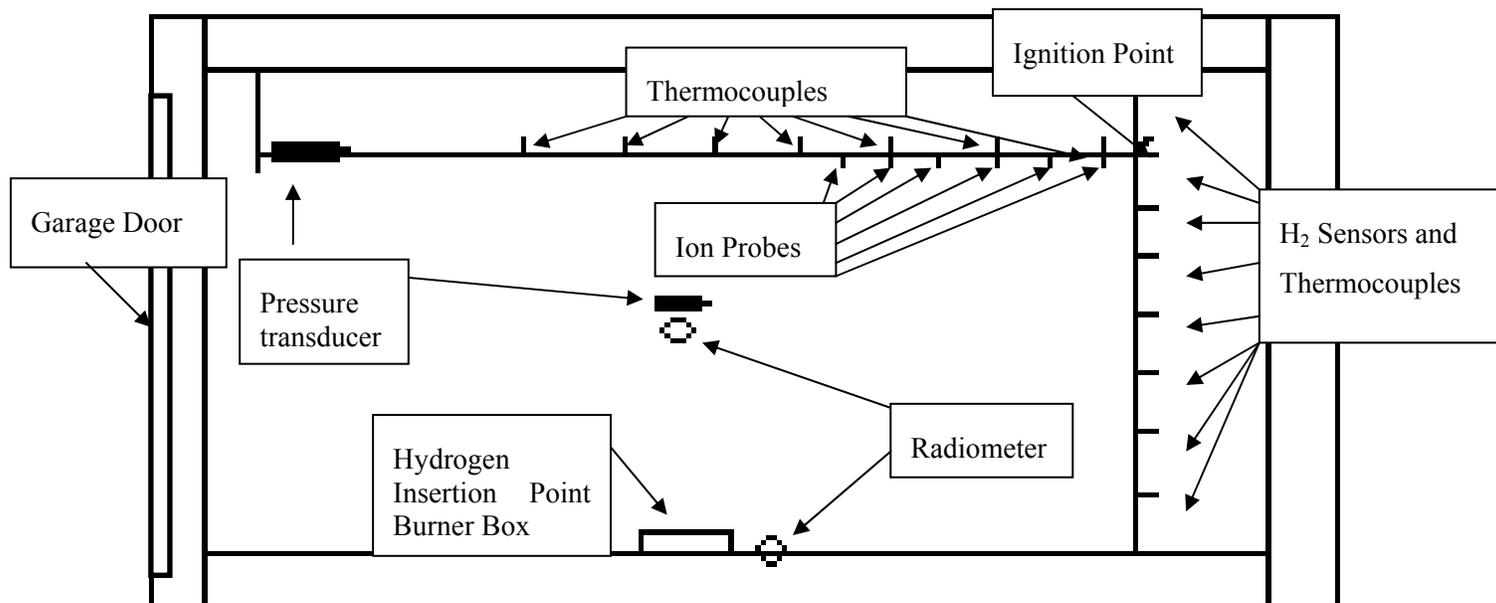
Figure 5. Side View Cutaway of Garage Simulator.

Figure 5 shows the positioning of critical sensors in a cut-away schematic side view of the garage. This figure represents the as-built garage which was modified to have thermocouples on the horizontal axis.

Ion probes were located at 30-cm intervals from the ignition point along the horizontal axis to the front of the garage. A total of six ion probes were installed to measure flame propagation velocity. An additional seven thermocouples were added after the initial 8 % and 16 % tests along this axis located at 30 cm, 90 cm, 150 cm, 210 cm, 270 cm, 330 cm, and 390 cm from the ignition point.

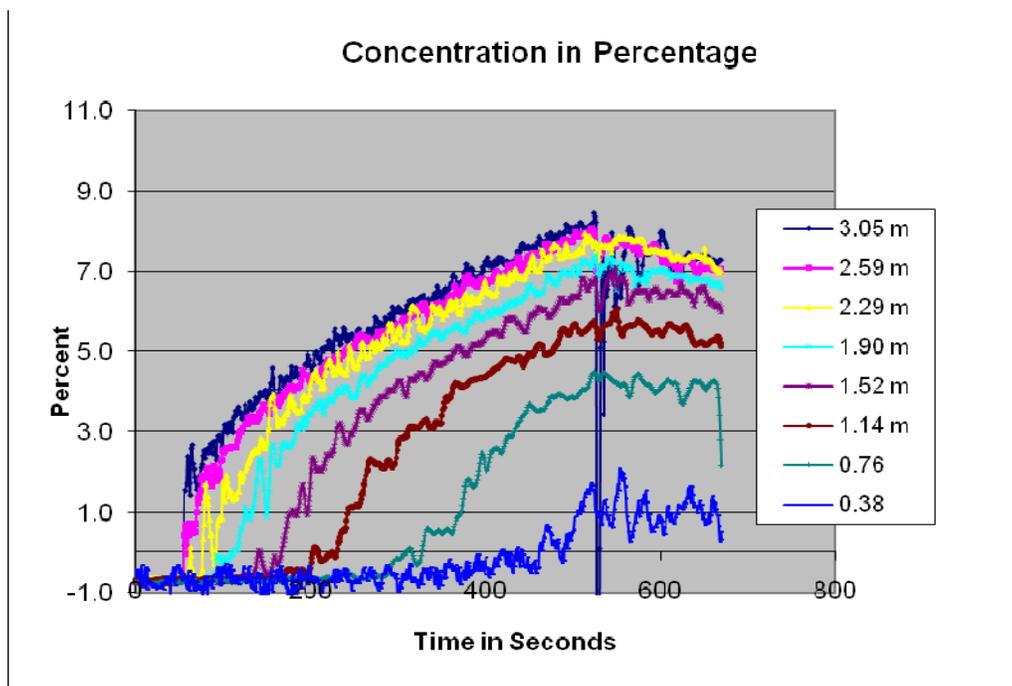
Figure 6. Hydrogen Concentration Profiles for Test 10/16/09, 8 %-6.

The 8 % runs were all very consistent with no damage to the garage and flame front velocities measured at between 0.34 m/s and 0.74 m/s. These runs were not energetic enough to engage the high speed sensors for either the ion or pressure probes. This was difficult to explain until review of the IR camera data showed that the flame propagates up to the roof, travels along the roof in slow waves, repeatedly traveling back and forth from back to front. The burn did not extend down to the sensor level at the 2.59 m height above the floor. The hydrogen concentrations for the 8 % runs were highly stratified with 2.59-m to 1.52-m sensors reading approximately 8.5 % to 9 %, the 1.14-m sensor at 7 %, the 0.76-m sensor at 6 % and the 0.38-m sensor at 2 %. Only the 3.05-m sensor indicated an actual burn event with a rapid drop in concentration. A sample concentration profile for the 8 % tests is shown in Figure 6. There is a clear stratification of the hydrogen concentration. The point of ignition is shown at 535 s into the test with only the 3.05-m sensor showing a significant drop in hydrogen concentration, which quickly recovers. The big drop is likely due to the thermal pulse at this sensor. The thermocouple profile shows the corresponding temperature spike for the thermocouple at

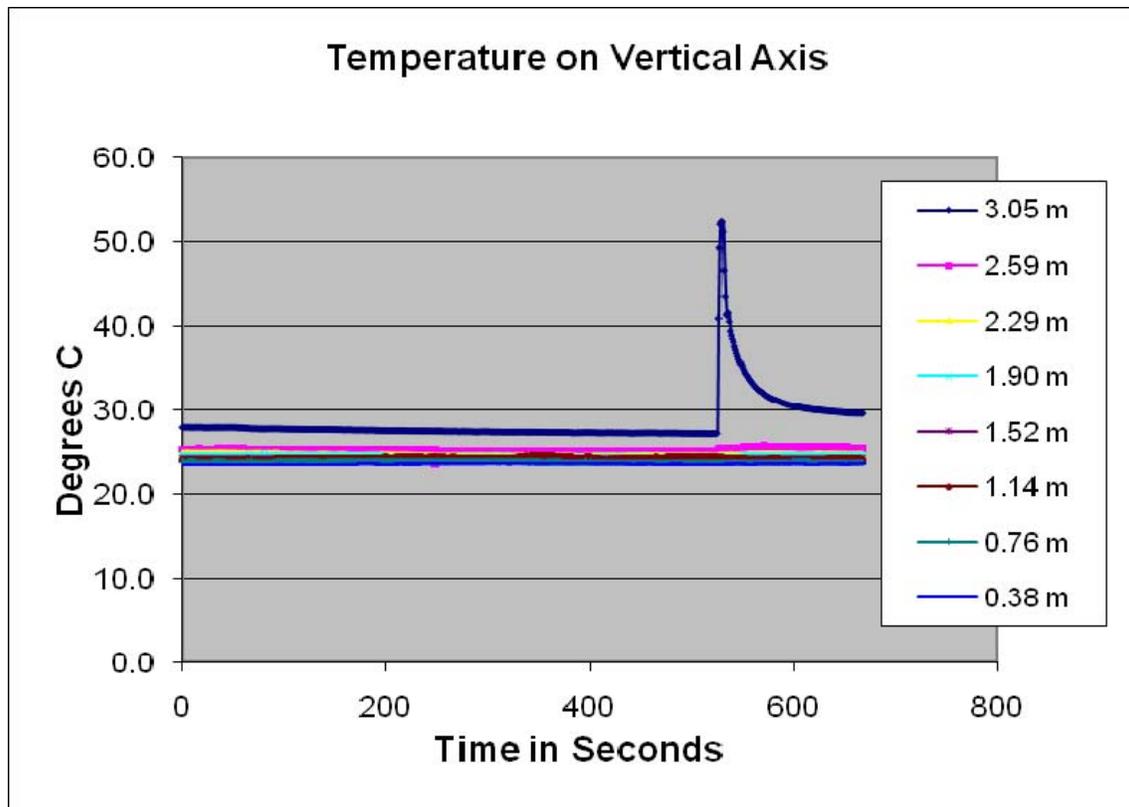
Figure 7. Temperature Profile for 10/16/09, 2-8 %-6 Test.

3.05 m, as seen in Figure 7. The IR video of the 8 % tests adds to the evidence that this type burn propagates from the 2.59-m ignition point upward to the ceiling and spreads laterally along the ceiling much like what is seen in a flashover event. The IR camera video revealed some interesting longer term processes that continued for several seconds, rolling waves of hydrogen flame appeared to traverse the ceiling along different axes. It is instructive to watch the entire sequence for each event. The energy of the event is not very exciting and is barely noticed in the visible spectrum as seen on the other video cameras. The radiometers had negligible responses to these events.

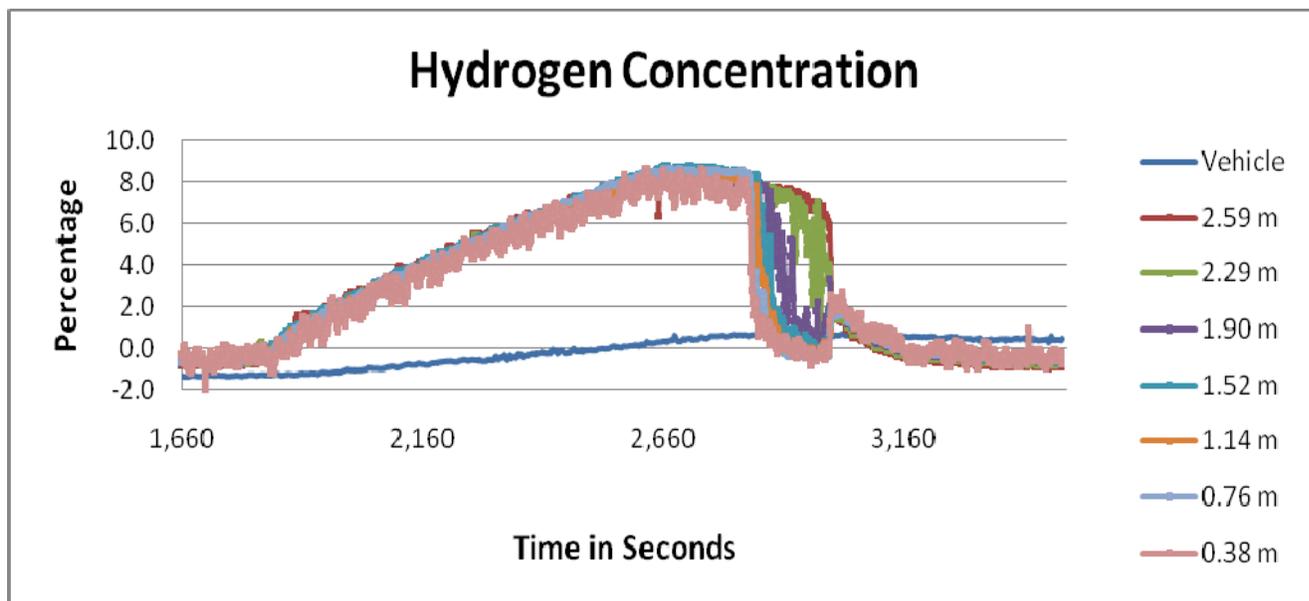
Figure 8. Hydrogen Concentration Profile of the 8 %-1V Test .

The addition of a vehicle to the garage radically upset the stratification. All sensors recorded roughly the same concentration as can be seen in Figure 8. In addition, the presence of the vehicle induced a major change in the burn behavior. A similar flame to the cases without vehicle was seen spreading along the roof, but the flame did not extinguish in the same manner. It continued to burn at a location above the engine compartment of the vehicle between the 2.59-m and 3.05-m heights. This torch-like flame burned for several minutes and was clearly visible in the IR video. Comparison of the concentration profile in Figure 8 to the temperature profile in Figure 9 shows an interesting correlation between the flame continuing to burn and heating of the sensor at the 3.05-m height. Comparing these results to the IR video explains this phenomenon with the observation of the torch-like burn. The hydrogen trapped in the engine compartment appears to have been released slowly enough to maintain the combustion for an extended period. The hydrogen concentrations in the passenger compartment indicate that it was fairly well sealed before the test and that hydrogen did not build up to a dangerous level.

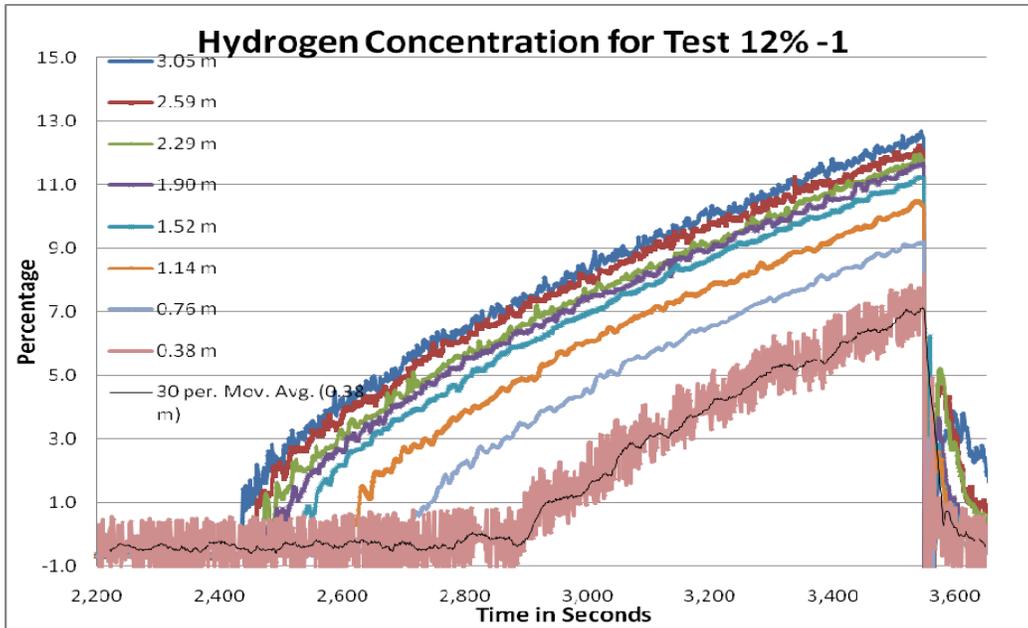
Figure 10. Hydrogen Concentration Profile from Test # 09/23/09, 12 %-1.

The 12 % runs were all very consistent with minimal damage resulting to the front wall of the garage and the flame front velocity measured at between 1.3 m/s and 2 m/s. A total of five 12 % runs without a vehicle were conducted. The last two runs had an IR camera installed to complement the results from the ion probes. The flame front appeared to accelerate and then decelerate. Some of these runs did trigger the data acquisition system for the pressure sensors and ion probes. The hydrogen concentrations for the 12 % tests were highly stratified, but the degree of stratification seemed to be dependent on the weather conditions and inward leakage rate. The damage to the structure for the non-vehicle runs was primarily detachment of the front wall at the upper left corner. The effect of the deflagration was a slow pressure increase that was non-shattering. The wall was easily repaired and resealed. Figure 10 shows an example to illustrate the degree of hydrogen concentration stratification. Figures 11 and 12 show representative vertical and horizontal temperature profiles from the 12 % tests. It is important to note that the 12 % runs resulted in burning down to the 0.38-m level as indicated by both the temperature and the hydrogen concentration measurements.

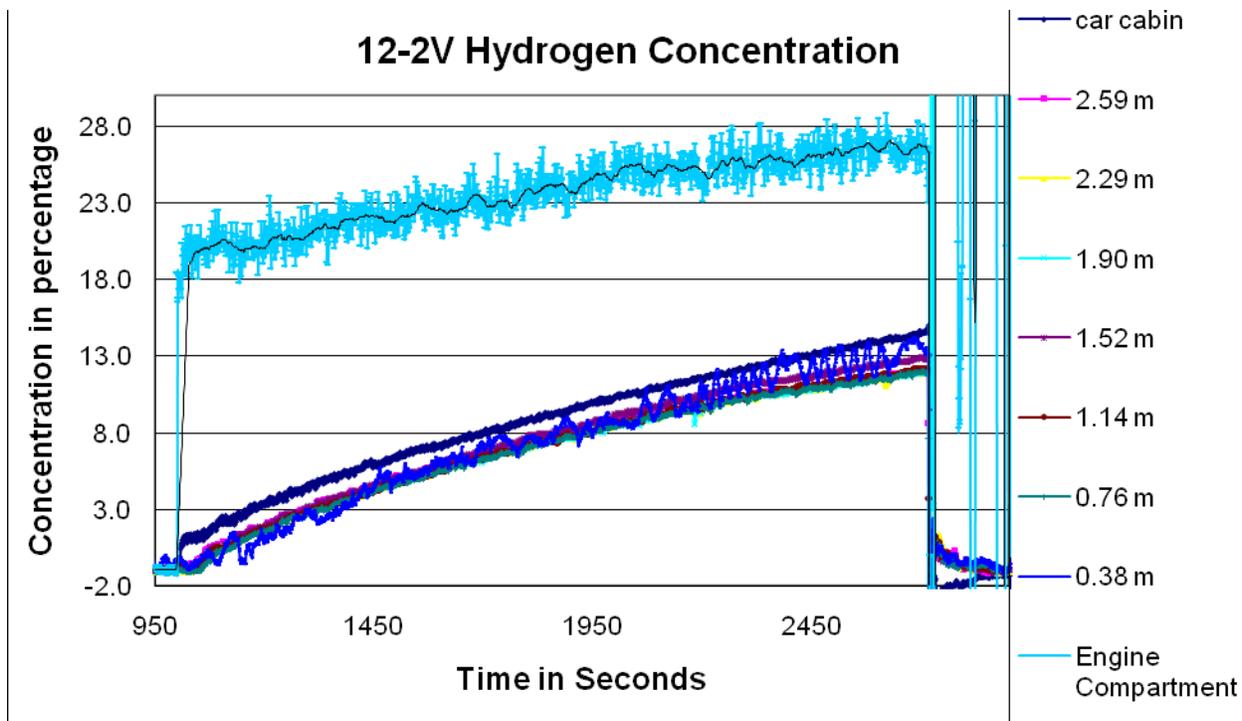
Figure 13. Hydrogen Concentration for Test # 10/30/09, 12 %V2.

The addition of a vehicle to the garage radically upset the hydrogen concentration stratification. The concentrations at different heights were within the range of 11 % to 13 % hydrogen as illustrated in Figure 13. An additional sensor was placed inside the engine compartment of the vehicle to determine the cause for the secondary combustion event seen in earlier vehicle runs. The concentration in the engine compartment rose to 19.5 % immediately and then climbed to 27 % at the time of ignition. The flame speed and a secondary combustion event are clearly visible in the IR video. The timing and sequence clearly indicate that combustion initiated at the ceiling took approximately 1.5 s to 2 s to reach the bottom of the vehicle where it then ignited hydrogen built up in the engine compartment with shattering effect. Both 12 %-with-vehicle tests behaved the same, with major damage to the vehicle and structure. The size and configuration of the engine compartment appears to be a major factor in the amount of damage observed.

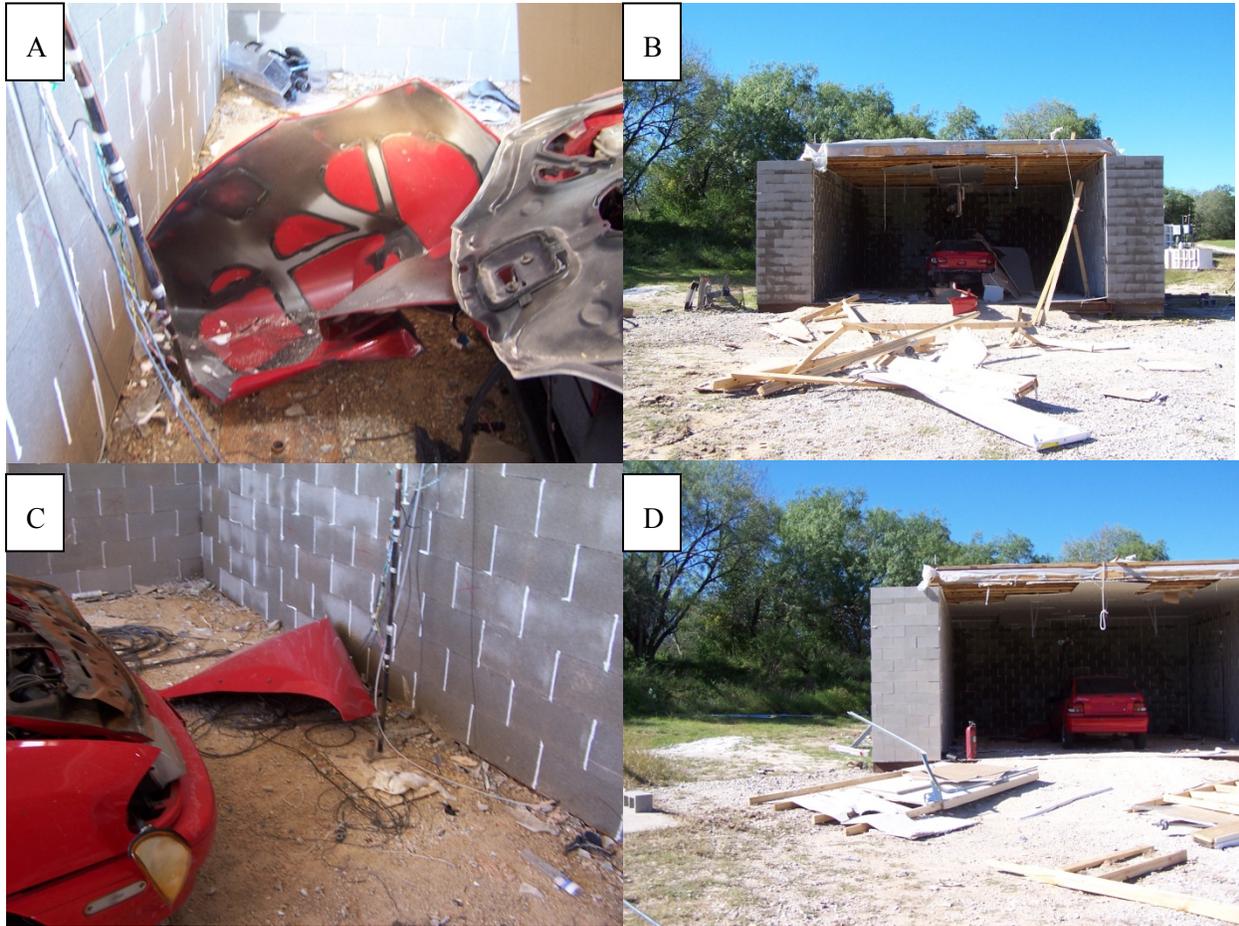
Figure 14. 12 % with Vehicle Damage Photos (A and B-Cavalier, C and D-Aspire).

The first vehicle was a Chevy Cavalier and the second was a Ford Aspire. The presence of the Cavalier caused significantly more damage to the structure, resulting in loss of the roof beams. This vehicle did not have much damage to windows or door, which is attributed to the low hydrogen concentration measured inside of the vehicle passenger compartment. The sheet metal of the engine compartment hood was blown off, acting as a projectile that destroyed the sensor rail above the vehicle. The back bumper blew off. The Ford Aspire was leakier in the passenger compartment and built up to 14.6 % hydrogen prior to ignition. The sheet metal of the engine compartment hood again was blown off, destroying the sensor rail above the vehicle. The glass windows in the driver door fragmented into small shards. The underside of the vehicle also ignited in this test. Much less damage was done to the garage from this test than for the Cavalier test. Figures 14A–D show both vehicles and the damage to the garage (A and B are of the Cavalier and C and D are the Aspire).

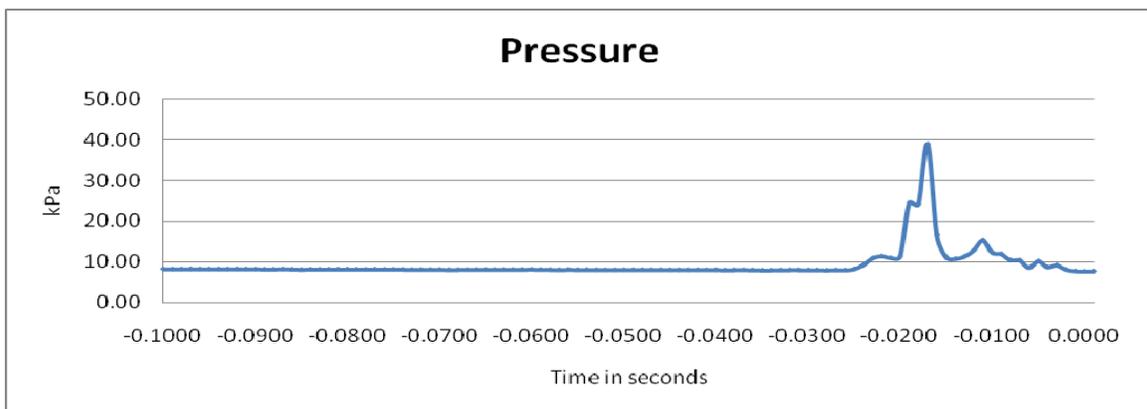
Figure 15. Sample Pressure Impulse from Test # 10/30/09, 12 %-2V.

Table 4 give a summary of the data obtained for the 12 % tests. Additional temperature and hydrogen sensors were used for several of the runs. The concentration at the time of trigger impacts the temperatures achieved, the speed of the flame front, and the height down to which the burn extends. In the final test, 12 %-2V, there was a significant impulse pressure of very short duration. The expanded time scale pressure measurements on the wall pressure sensor are shown in Figure 15. The pressure impulse is approximately 31.7 kPa (4.6 psi) and has an impulse time span of about 5 milliseconds

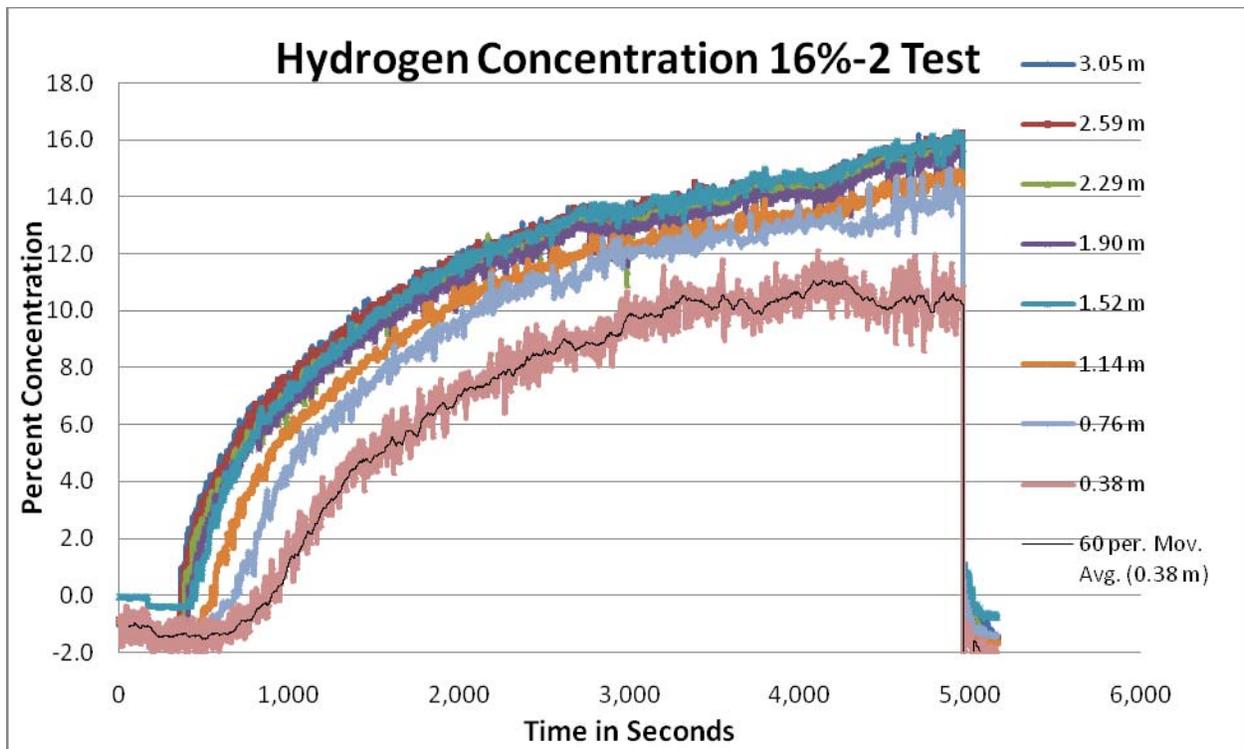
Figure 16. Hydrogen Concentration Profile Test # 09/18/09, 16 %-2.

A total of five 16 % runs were conducted, three without vehicle and two with vehicle. All of the 16 % tests without vehicle did damage to the structure, completely blowing out the front wall with debris traveling up to 9 m. These tests generally raised the roof a few inches to a foot before it returned to its original position as designed. There was some loss of gypsum board from the ceiling. All of the thermocouples and hydrogen sensors survived the test unless directly struck by falling gypsum board. Figure 16 shows the hydrogen concentration stratification for a 16 % test. Significant amounts of hydrogen built up even down to the 0.38 m height above the floor. Consumption of the fuel following ignition around 5000 s is more complete than seen in the 12 % runs. The temperature data shows significant temperature rises down to the 0.38 m height and along the horizontal axis in Figures 17 and 18.

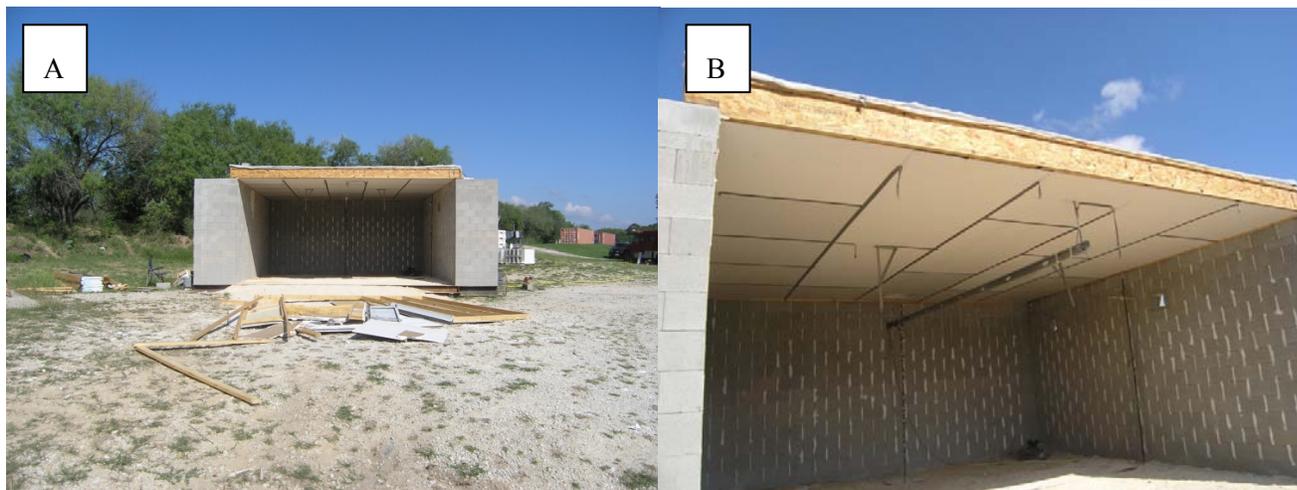
Figure 19. Destruction caused by 16 % Tests without Vehicle.

The 16 % tests were very consistent in the damage done to the structure. The pictures shown in Figures 19A and 19B exhibit common results observed for the tests with this concentration. Debris was launched 9 m at the furthest point from the structure, and the high speed video clearly shows the event to be a relatively low speed push of the front wall until it detaches with the roof moving upwards about 0.3 m before again settling down onto the intact block walls.

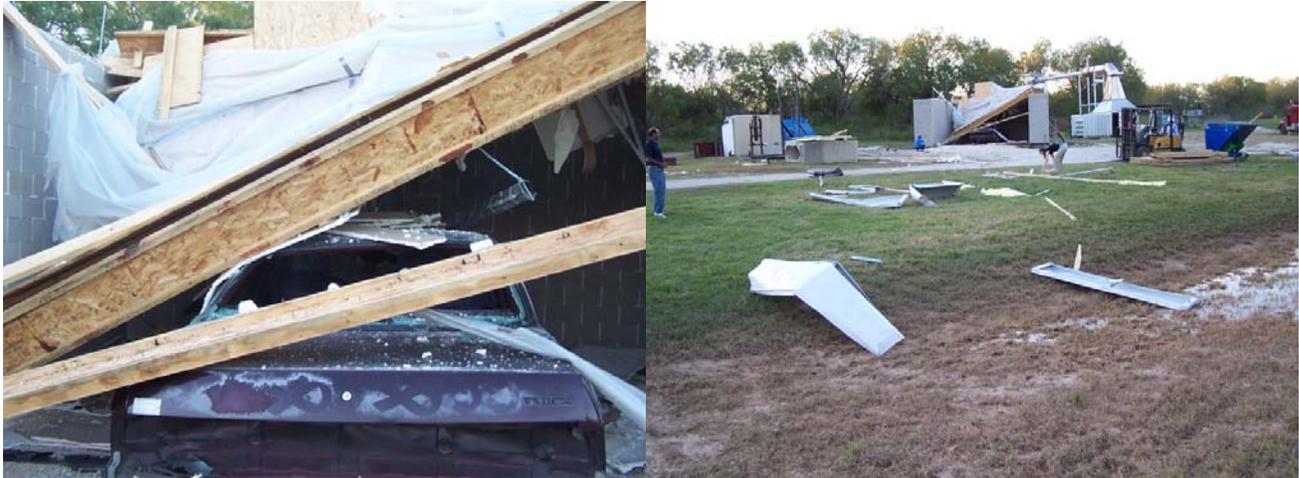
Figure 20. Damage caused by Test # 11/4/09, 16 %-1V.

Inclusion of a vehicle in the garage radically changes the degree of damage caused by the 16 % hydrogen concentration. A two-stage event was seen that was similar to those observed during the vehicle tests for the 12 % runs. The data acquisition system overloaded from the high speed data and the hydrogen concentration data was lost shortly after ignition for Test 16 %-1V, but at the time of the ignition the concentration inside the engine compartment was approximately 28 %, the concentration inside the vehicle was greater than 16 % and the concentration inside of the garage was right at 16 %. The garage required 58 min or 3480 s to fill. Excellent high speed data was obtained from the pressure sensors and the ion probes. The high speed video captured the two stage event very clearly with a slow deflagration pushing out the wall, a flash occurring at 0.05 s into the event and a subsequent dramatic increase in the rate of the breakup of the front wall and ceiling of the building. Debris was spread to a distance of greater than 30.5 m, with much smaller pieces being generated. Pictures of the debris field are included in Figure 20 for comparison to the non vehicle case. The vehicle used in the test was a Buick Century Limited. This is an indication that vehicle size was especially important, due to the larger amounts of hydrogen that can be trapped in the engine compartment, passenger compartment and, in this case, the trunk. Most of the vehicle glass was blown out, the rear bumper was blown off, traveling 24.4 m, but remaining as a single piece, and a small fire was started in the trunk space of the car. In the second vehicle test at 16 % hydrogen, a BMW 325i was used. This vehicle has smaller interior volumes than the Buick Century and much less damage was caused by the fire, with the roof of the structure surviving the event and debris projected out to 24.4 m.

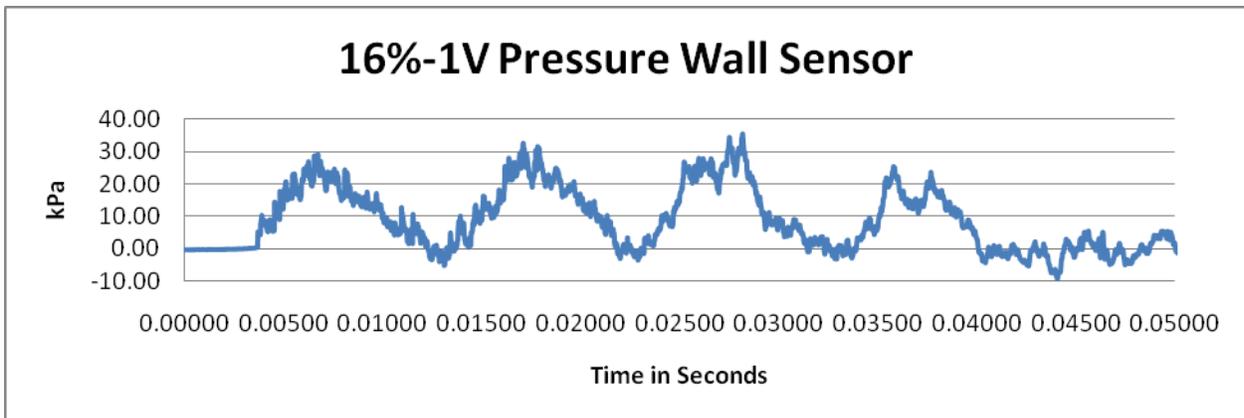
Figure 21. Pressure measured at the wall for Test # 11/4/09, 16 %-1V.

Impulse pressures from Test 16 %-1V are shown in Figures 21–23. A rolling pressure wave with a magnitude of 27.5 kPa (4 psi) was measured at the wall as shown in Figure 21. The rolling wave is also seen in the pressure plot for the sensor near the door with a peak magnitude of 57.9 kPa (8.4 psi) followed by a second, much narrower impulse of 55.2 kPa (8 psi), and a single data point reading 406 kPa (59 psi) as shown in Figure 22. This one data point is likely aberrant. Figure 23 shows the expanded region for the impulse. All of the peaks in this region have definite structure (a multiple point rise and fall of intensity, not random noise) except the

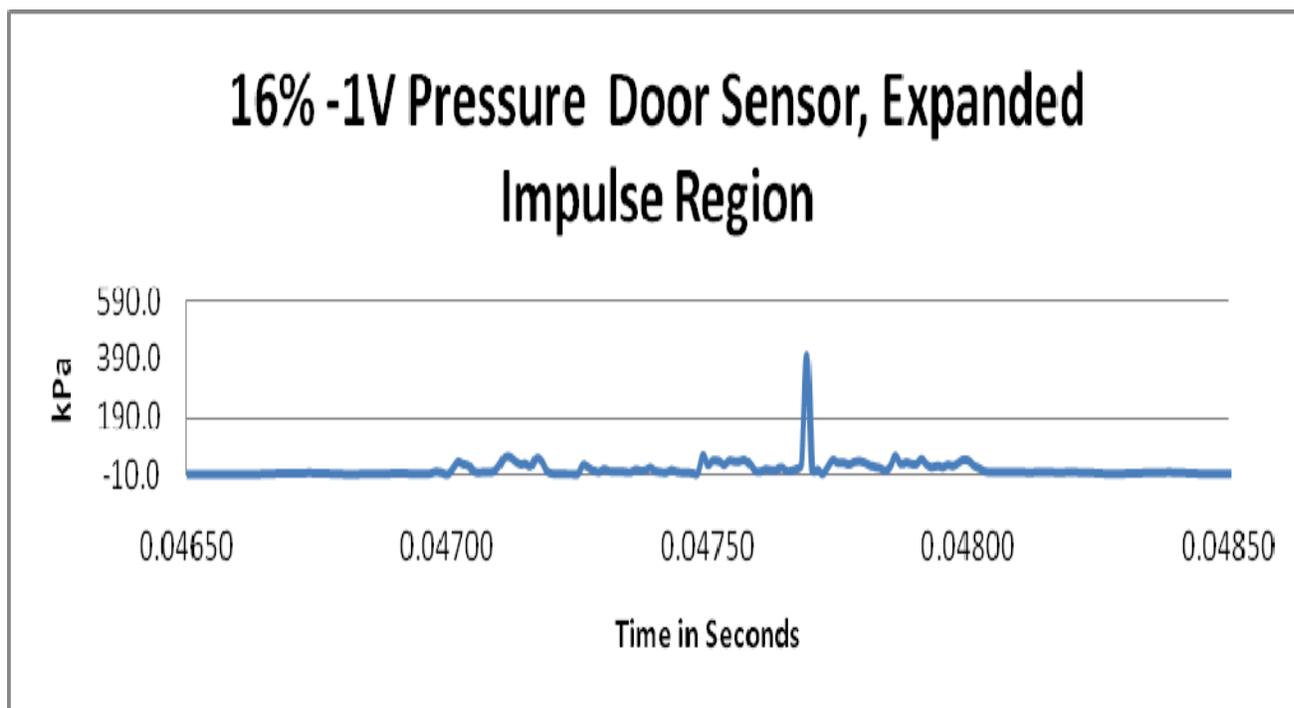
Figure 23. Expanded Garage Door Pressure Sensor for Test # 11/4/09, 16 %-1V.

single intense peak. The intense peak may be due to an impact on the sensor of a hard object or an electrical spike in the sensor caused by the disassembly of the building.

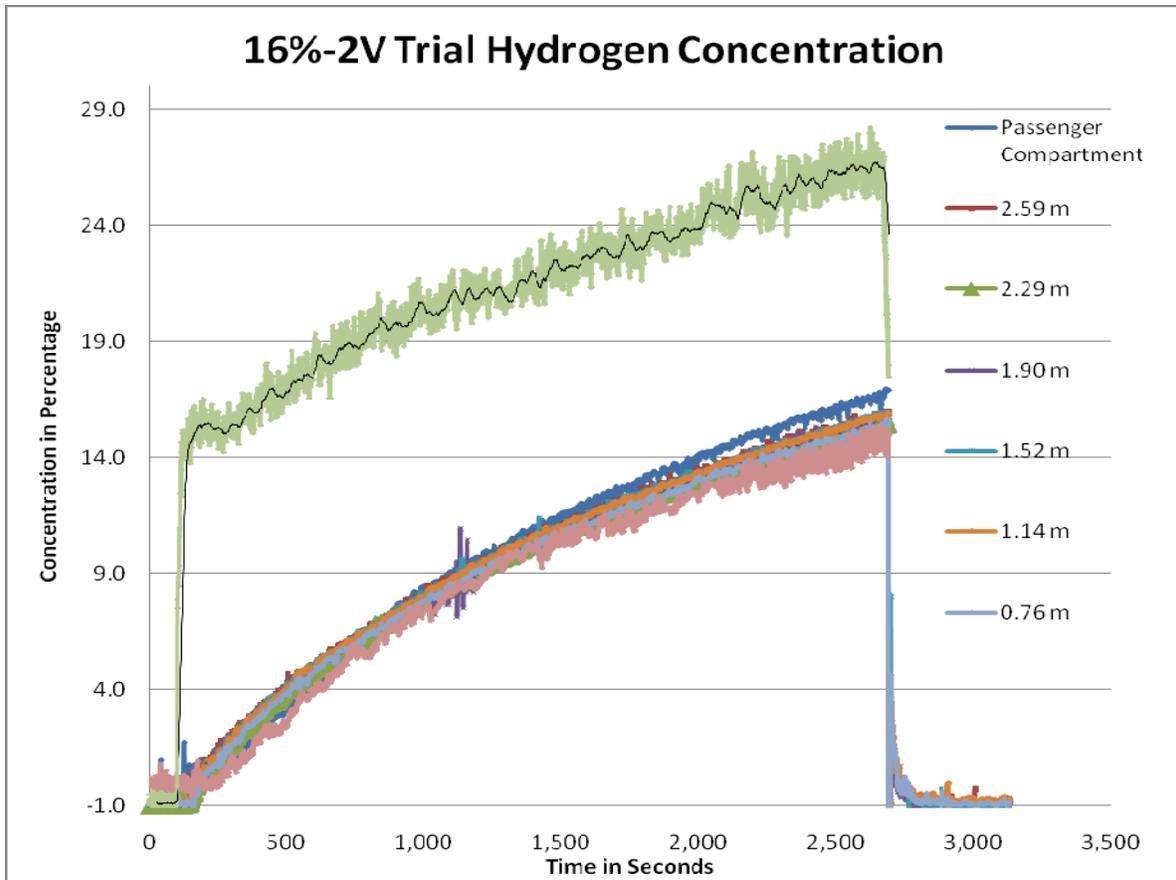
Figure 24. Hydrogen Concentration Profile for Test # 11/12/09, 16 %-2V.

The low speed DAC system functioned during the entire test for Test 16 %-2V. The concentration data clearly shows the disruption of the hydrogen stratification in the garage. The engine compartment trapped significant hydrogen concentrations, but the concentration dropped significantly due to leakage from the compartment between the times of hydrogen flow cut-off and burn ignition. The subsequent damage to the structure was less than for Test 16 %-1V, but still significant. High speed data did not record for the trigger event but was recorded due to erroneous multiple triggers prior to the event. High speed camera video shows clearly the same sequence of events as observed for earlier tests with vehicles. A two stage event with a relatively slow burn occurred followed by acceleration and rapid destruction of the garage front wall. Figure 24 shows the hydrogen concentration profiles for this event. The radiometer reading for this test was interesting, giving the highest values observed at 13 W/m^2 as seen in Figure 25. Peak temperature measurements were consistent with those seen in tests without a vehicle.

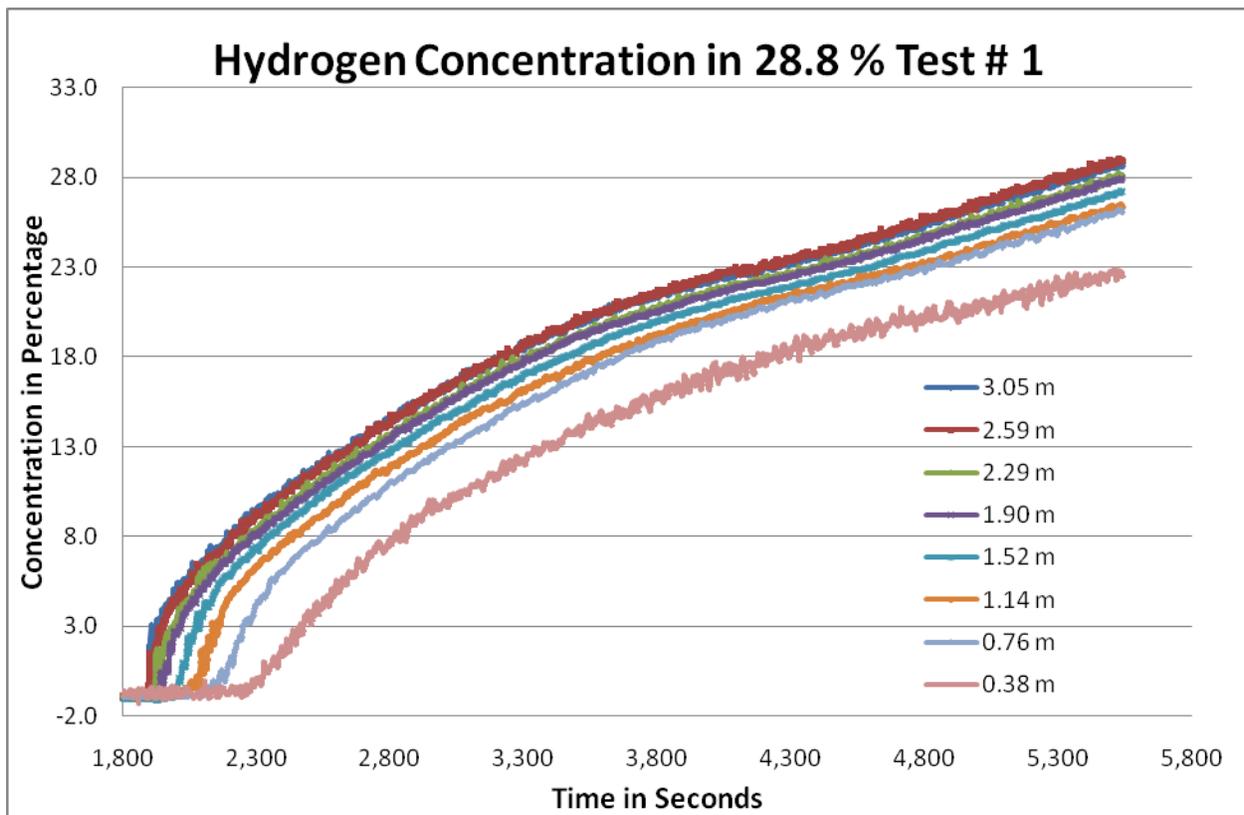
Figure 26. Hydrogen Concentration Profile for Test # 10/1/09, 28.8 %-1 .

A single test was conducted at 28.8 % hydrogen concentration without a vehicle. The hydrogen concentration in the structure was still mildly stratified with the lowest layers having concentrations above 20 %. Figure 26 shows the measured hydrogen concentration profile. The filling process required 60.8 minutes to reach 28.8 % using 4.9 kg of hydrogen at a flow rate

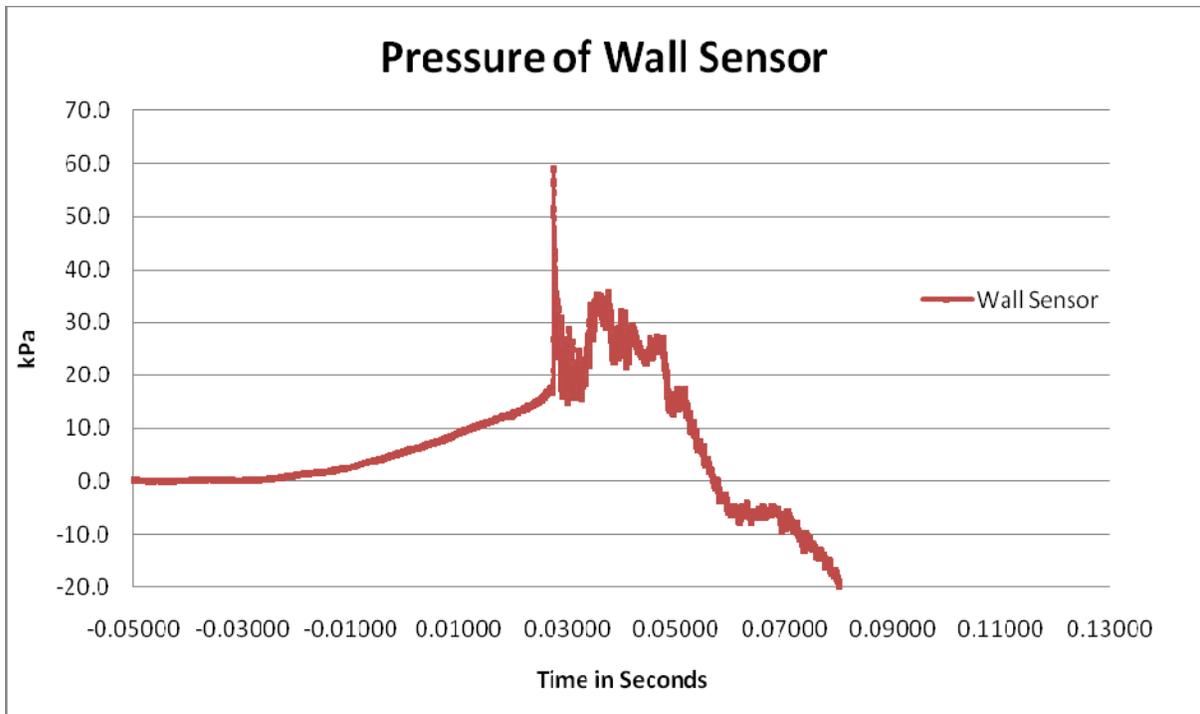
Figure 27. Pressure Sensor Results for the Wall PT for Test # 10/1/09, 28.8 %-1.

of 983 SLPM. Both high speed and low speed data were successfully collected. The damage to the garage was devastating, requiring rebuilding of the garage concrete block walls. The walls split at the corners, all of the welded rebar snapped at their weld points to the I-beam frame, and the wing walls were moved about 0.2 m from their original position. Roof pieces traveled upward between an estimated 18.2 m to 24.4 m, and front wall pieces were projected up to 45.7 m from the front of the structure. All of the low speed temperature and concentration data abruptly cut off near the time of ignition due to loss of the data cables, so no heat flux or temperature data is available after this time. The ion probes and pressure transducers did capture high speed data before the signals were lost. These results are shown in Figures 27 and 28. For the wall sensor, a gradual build up in pressure was seen to approximately 17.2 kPa (2.5 psi) over a period of 49 ms, with an abrupt rise to 59.3 kPa (8.6 psi) at the wall in a very short 70 μ s with an impulse width of 320 μ s. The slow rise was consistent with a deflagration. The abrupt rise and narrow impulse are consistent with a transition to detonation (DDT). A DDT normally requires transition to a burn velocity that is greater than the speed of sound, which presumably took place somewhere within the vehicle. Similar pressure behaviors were also observed by the pressure transducer located on the rail near the ceiling.

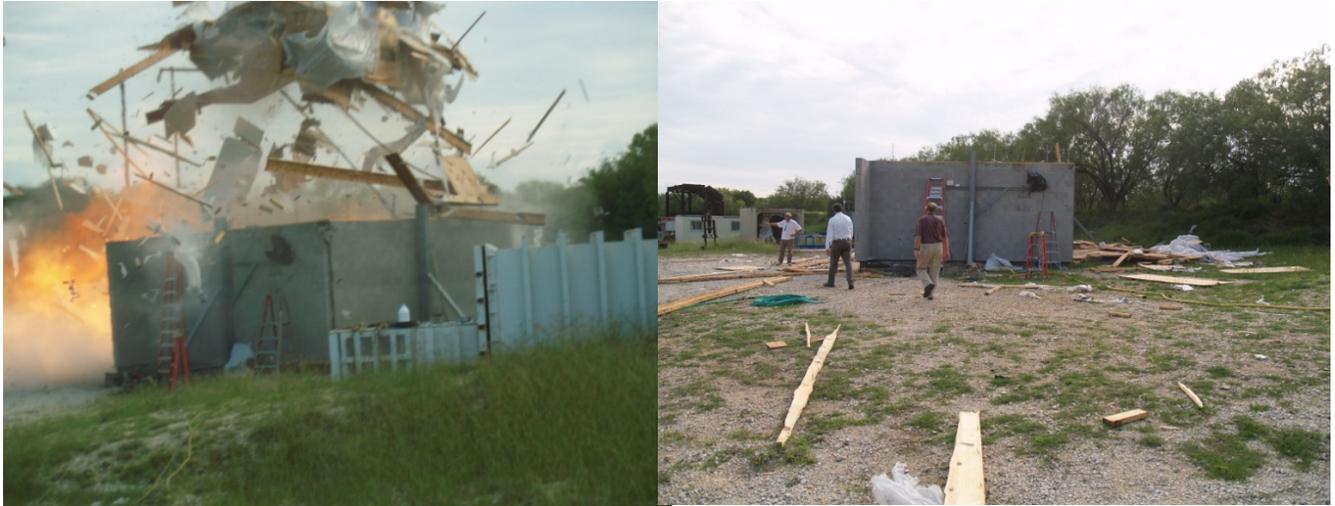
Figure 29. 28.8 % Test Damage Photos.

The degree of damage to the building was catastrophic, as stated previously. The photos included in Figure 29 show the degree of damage and debris projection for this test. High speed video captured the test as a continuous event with no noticeable transitions.
