**HYDROGEN RELEASE AND
COMBUSTION MEASUREMENTS IN A
FULL SCALE GARAGE**

Final Test Report

Contract SB134109SE0612
SwRI® Project No. 01.15071

SOUTHWEST RESEARCH INSTITUTE®
6220 Culebra Road • P.O. Drawer 28510
San Antonio, Texas 78228-0510

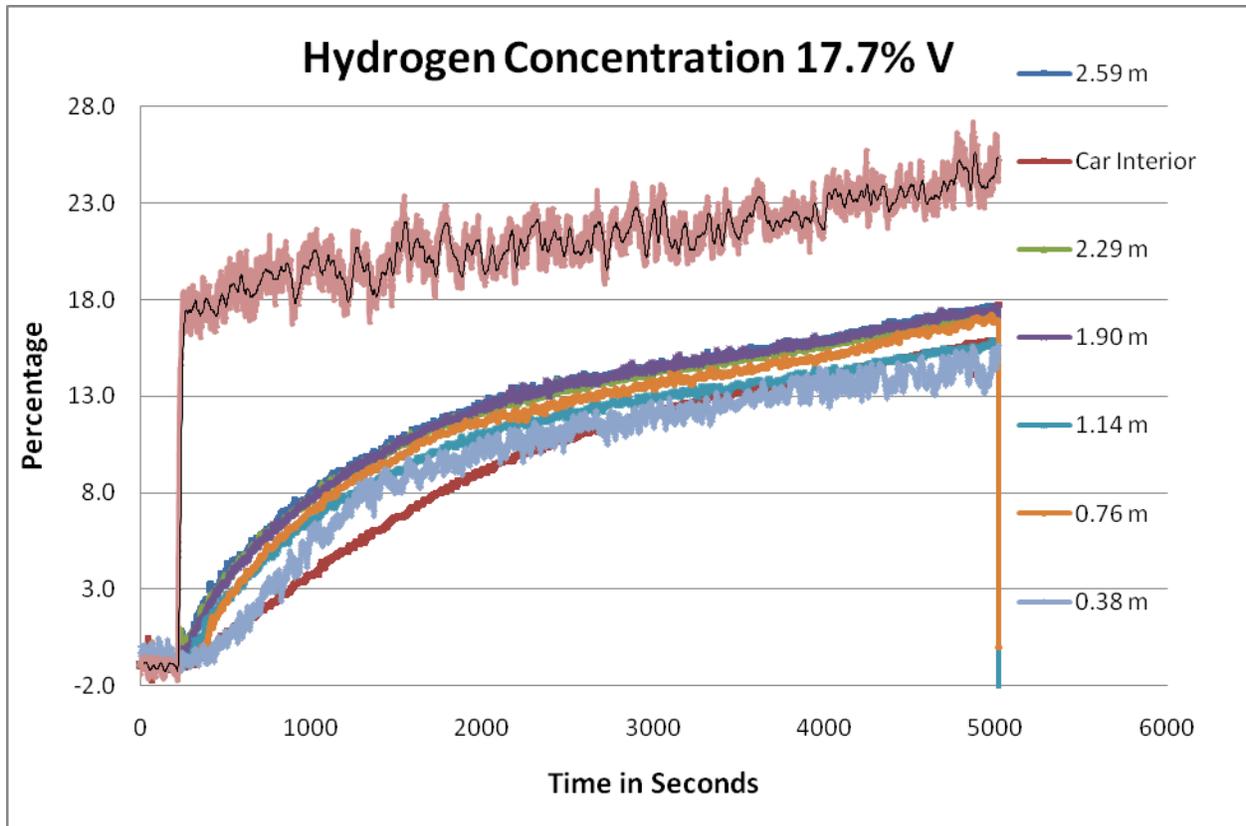
Figure 30. Concentration Profile for Test # 11/23/09, 17.7 %V.

The 17.7 %V test conducted with the vehicle only reached a peak room concentration of 18 % at the ignition point for a fill time of 4738 s (1 h and 19 min). The intent had been to reach a hydrogen concentration of 28 %. The lower value was likely due to the higher inward leakage rate of the building with $(ACH)_4$ measured to be 4.1. The burn was ignited at this time due to the slow rate of hydrogen concentration increase and concerns over loss of daylight required to capture high speed video of the event. The vehicle engine compartment (Ford Explorer) shows a rapid hydrogen concentration rise to 18 % in the first 40 s, with a slow rise to 25 % over the duration of the fill time. Stratification of the hydrogen concentration in the room was completely upset by the inclusion of a vehicle as was seen in all previous vehicle tests. Figure 30 depicts the continuous concentration readings of the room, engine compartment and passenger compartment. The hydrogen sensor at 1.52 m was not operational for this test, but this was not deemed to affect the quality of the data. All concentrations were in a very narrow band, except for the engine compartment which was considerable higher.

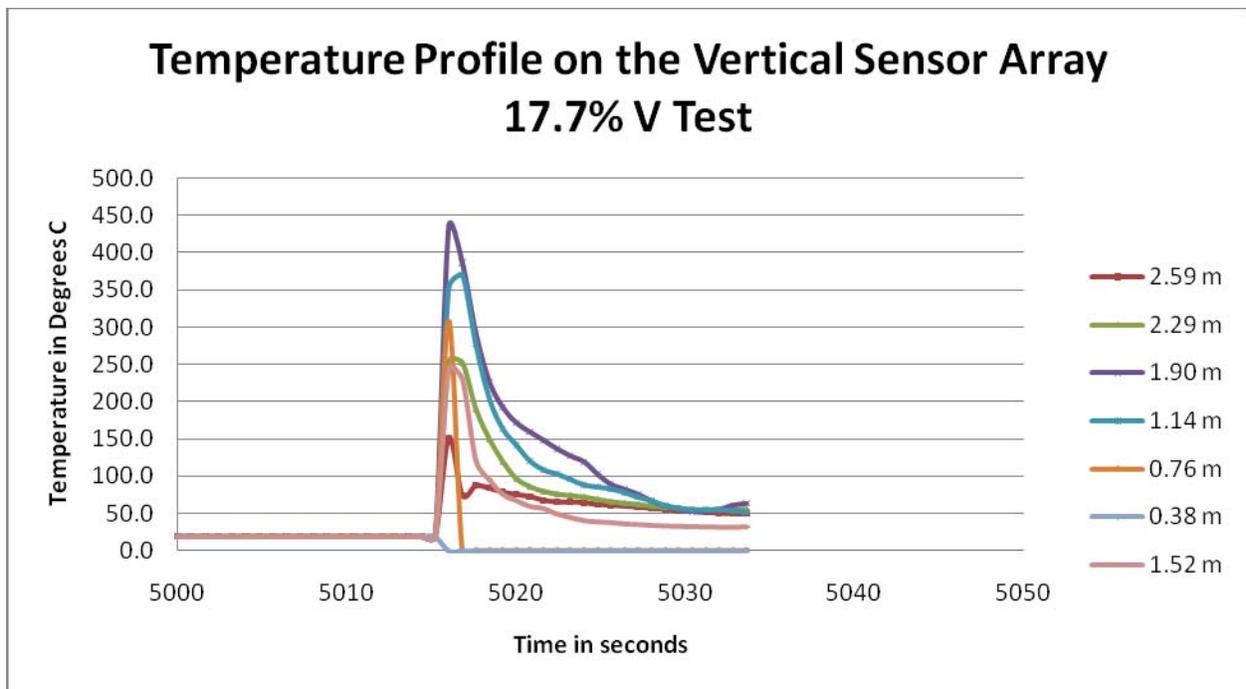
Figure 31. Vertical Array Temperature Profile for Test # 11/23/09, 17.7 %V.

Due to the rapid destruction of the building, the post trigger temperatures on the horizontal array were only recorded for a very short time following ignition, and the data are somewhat suspect. The temperature spikes are of very short duration (1 data point) and may correspond to signals generated during the destruction of the sensor array. The temperature profiles for the vertical thermocouple arrays are shown in Figure 31.

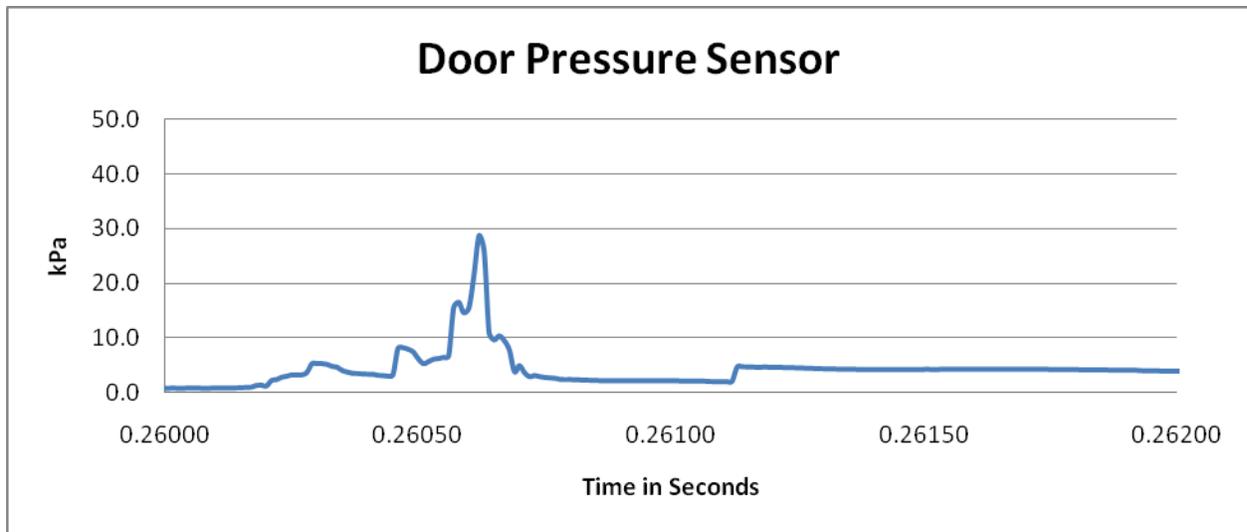
Figure 32. Door Pressure Sensor Data for Test # 11/23/09, 17.7 %V.

The high speed sensors did capture the event for both the flame propagation speed and the pressure profile. Figure 32 shows the measurements for the pressure sensor mounted on the rail in front of the garage door. The pressure event begins at approximately 0.208 s and the sensor appears to fail at approximately 0.264 s. The pressure peak at 0.261 s has structure (multiple data point pressure rise and fall which is consistent with random noise) and a peak pressure of 28.7 kPa (4.16 psi). The width of the impulse peak is 230 μ s (23 data points).

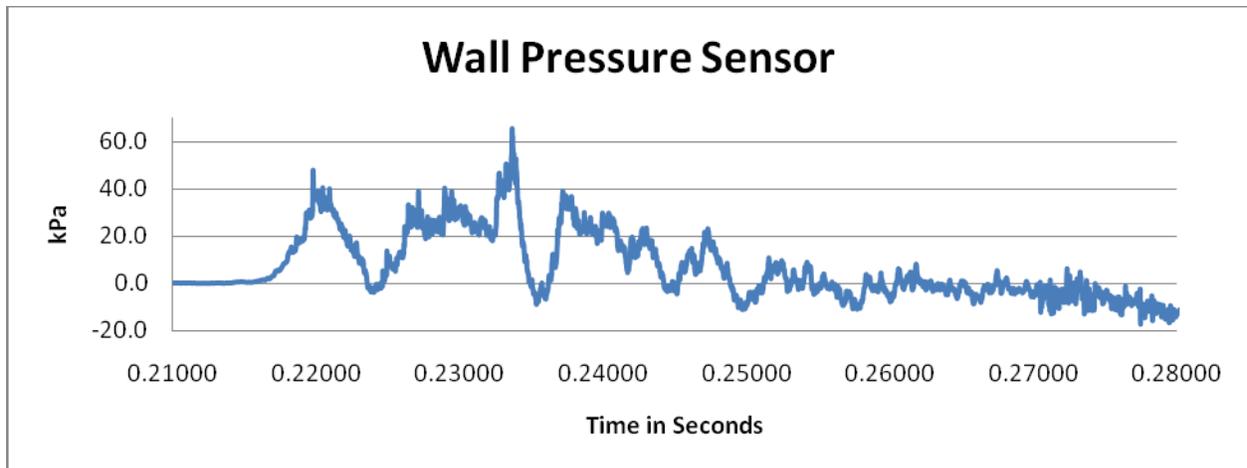
Figure 33. Wall Pressure Sensor Data for Test # 11/23/09, 17.7 %V Time Expanded.

The wall pressure sensor gives a very different pressure profile. The pressure appears as a series of broad pressure waves of between 34.5 kPa and 37.9 kPa (5.0 psi and 5.5 psi). It appears that the pressure impulse occurs in waves due to a non-continuous burn or reflective pressure impulses from the three fixed walls or both. Signal shows a gradual decay in wave intensity as would be expected for reflected pressure waves. There are also two, short duration impulses of 47.6 kPa (6.9 psi) and 65.5 kPa (9.5 psi) superimposed on the pressure waves. Figure 33 shows the wall pressure sensor data.

Figure 33. Wall Pressure Sensor Data for Test # 11/23/09, 17.7 %V Time Expanded..... 36

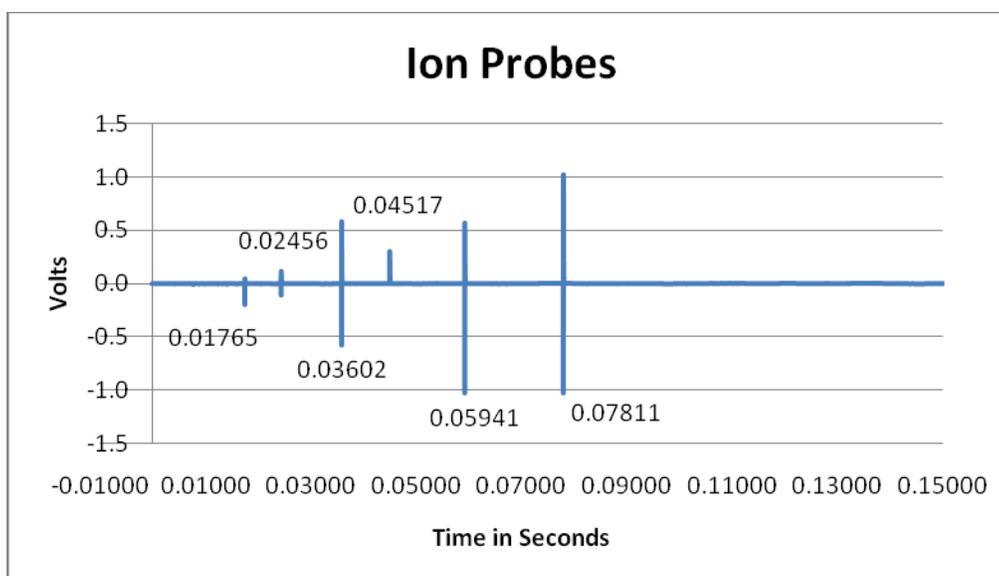
Figure 34. Ion Probe Data for Test # 11/23/09, 17.7 %V with Time Point for Each Peak (negative time is time before trigger of collection, data collected in the buffer).

The ion probes captured flame front passage for this test. The average burn velocity is calculated to be 24.0 m/s with individual values of 26.2 m/s, 32.8 m/s, 21.1 m/s, and 16.0 m/s. The same phenomenon of acceleration and deceleration was noted here as seen in other tests. Figure 34 presents the ion probe data captured during this test. Signal widths of 100 μ s (10 data points indicate real peaks).

Figure 34. Ion Probe Data for Test # 11/23/09, 17.7 %V with Time Point for Each Peak
(negative time is time before trigger of collection, data collected in the buffer)..... 37

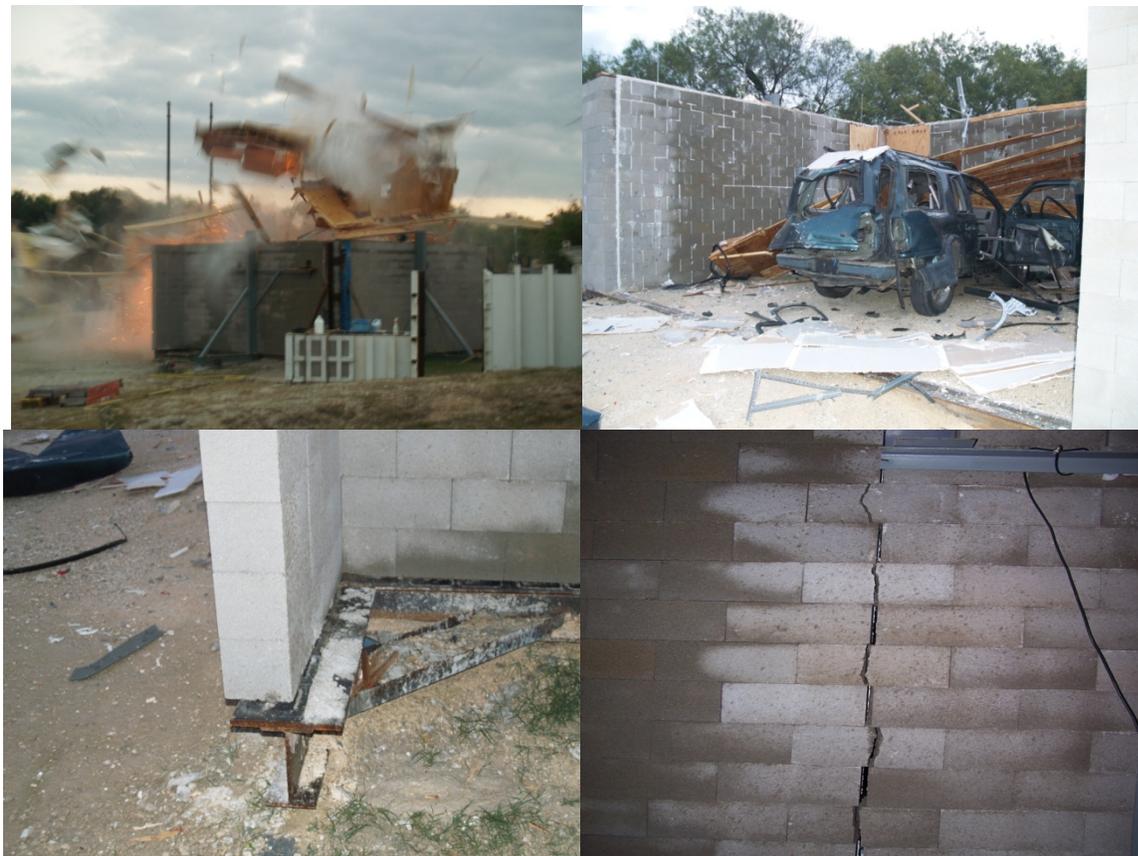
Figure 35. Damage Photos from the 28 %V Test.

Figure 35 shows examples of damage observed for the test with a vehicle included. This vehicle had a leaky passenger compartment with the hydrogen concentration reaching 13.7 %. The engine compartment was well sealed with little or no loss of hydrogen concentration during the period between termination of filling and ignition.

Table 6 shows a data summary for the two 28 % tests. Even though the hydrogen concentration in the garage only reached 17.7 % in the test containing a vehicle, the damage is comparable between the two tests. The concrete walls cracked and the welds at the foundation were sheared off. The ceiling and roof were completely destroyed, and fragments of the walls were projected over 30.5 m. Measured burn velocities were similar between the two tests. The longer fill time and lower effective concentration of the 17.7 %V test are attributed to both the higher leakage rate and the disruption of stratification in the room. The displacement volume of the vehicle can be ignored due to the fact that the concentration inside the vehicle was close to that seen in the room. The similarity in the damage seen is likely attributable to the trapped hydrogen in the engine compartment resulting in a more energetic event.
