Experimental Study on Tire Fire Penetration into a Motorcoach Passenger Compartment¹

Erik Johnsson² and Jiann C. Yang
Engineering Laboratory
National Institute of Standards and Technology
100 Bureau Drive
Gaithersburg, MD 20899, U.S.A.

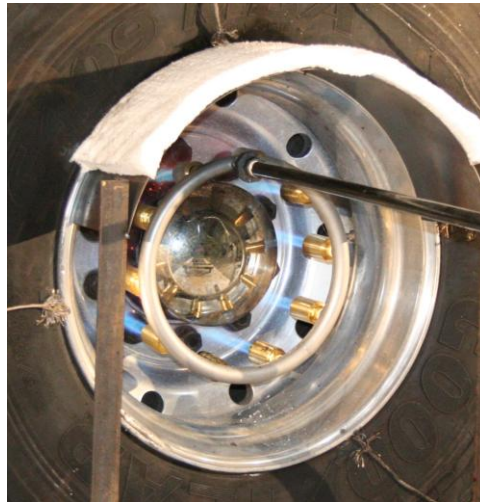
Figure 2. A schematic of the wheel burner design showing the relative locations of the torch heads and manifold compared to the wheel's hub, lug nuts, and lug nut covers (upper). The outer circle represents the wheel's curvature away from the lug nut surface plane. A photograph showing the tire shield nested inside a drive axle wheel rim with an insulating cover to minimize convective and radiative heating to the tire (lower).

Figure 2. A schematic of the wheel burner design showing the relative locations of the torch heads and manifold compared to the wheel's hub, lug nuts, and lug nut covers (upper). The outer circle represents the wheel's curvature away from the lug nut surface plane. A photograph showing the tire shield nested inside a drive axle wheel rim with an insulating cover to minimize convective and radiative heating to the tire (lower).

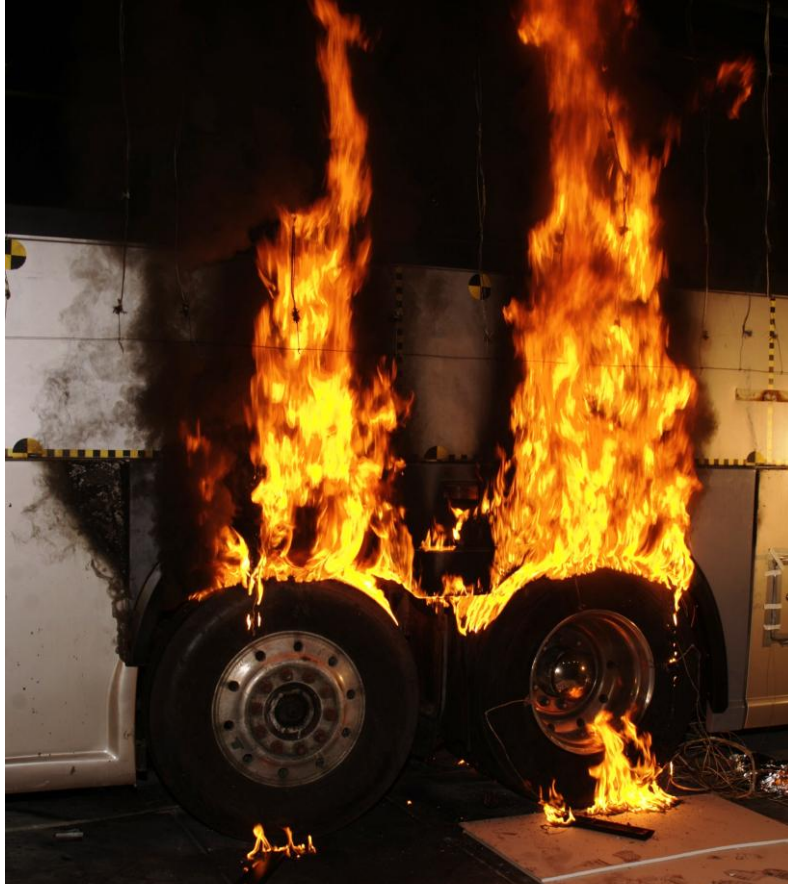
Figure 5. Drive axle wheel heating experiment about 30 s after burner was turned off.

Figure 5. Drive axle wheel heating experiment about 30 s after burner was turned off.
