ANALYSIS OF THE HAPPYLAND SOCIAL CLUB FIRE WITH HAZARD I

Richard W. Bukowski, P.E. and Robert C. Spetzler
Building and Fire Research Laboratory, NIST
Gaithersburg, MD 20899

SUMMARY

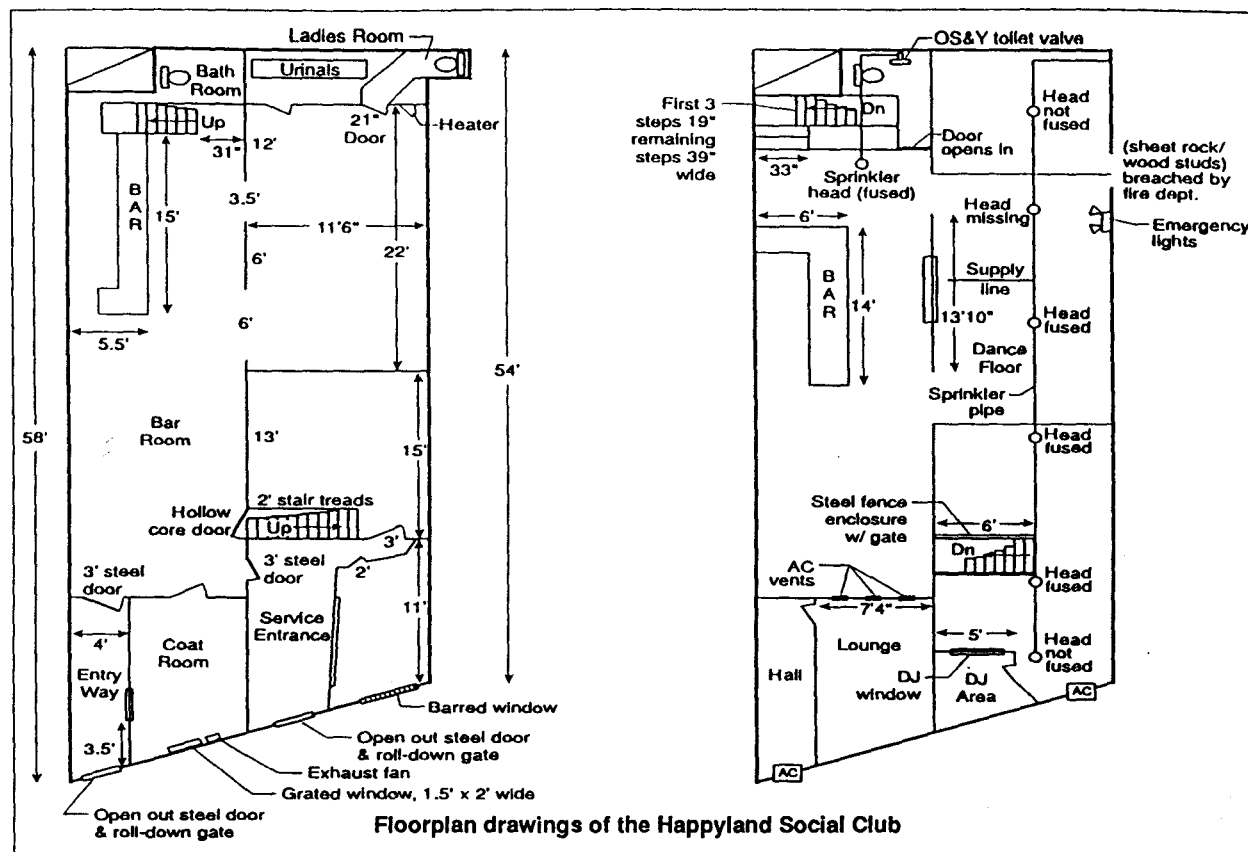
The floorplan drawings obtained from the New York City Fire Department are shown on the next page. Wall finish throughout the interior of the building was 3/16-inch thick wood paneling on furring strips over plaster. The ceilings were low density fiberboard tiles in the first floor entry and bar, and gypsum board elsewhere. The fiberboard tiles were installed on furring strips under the floor joists. Note the partial sprinkler system on the second floor.

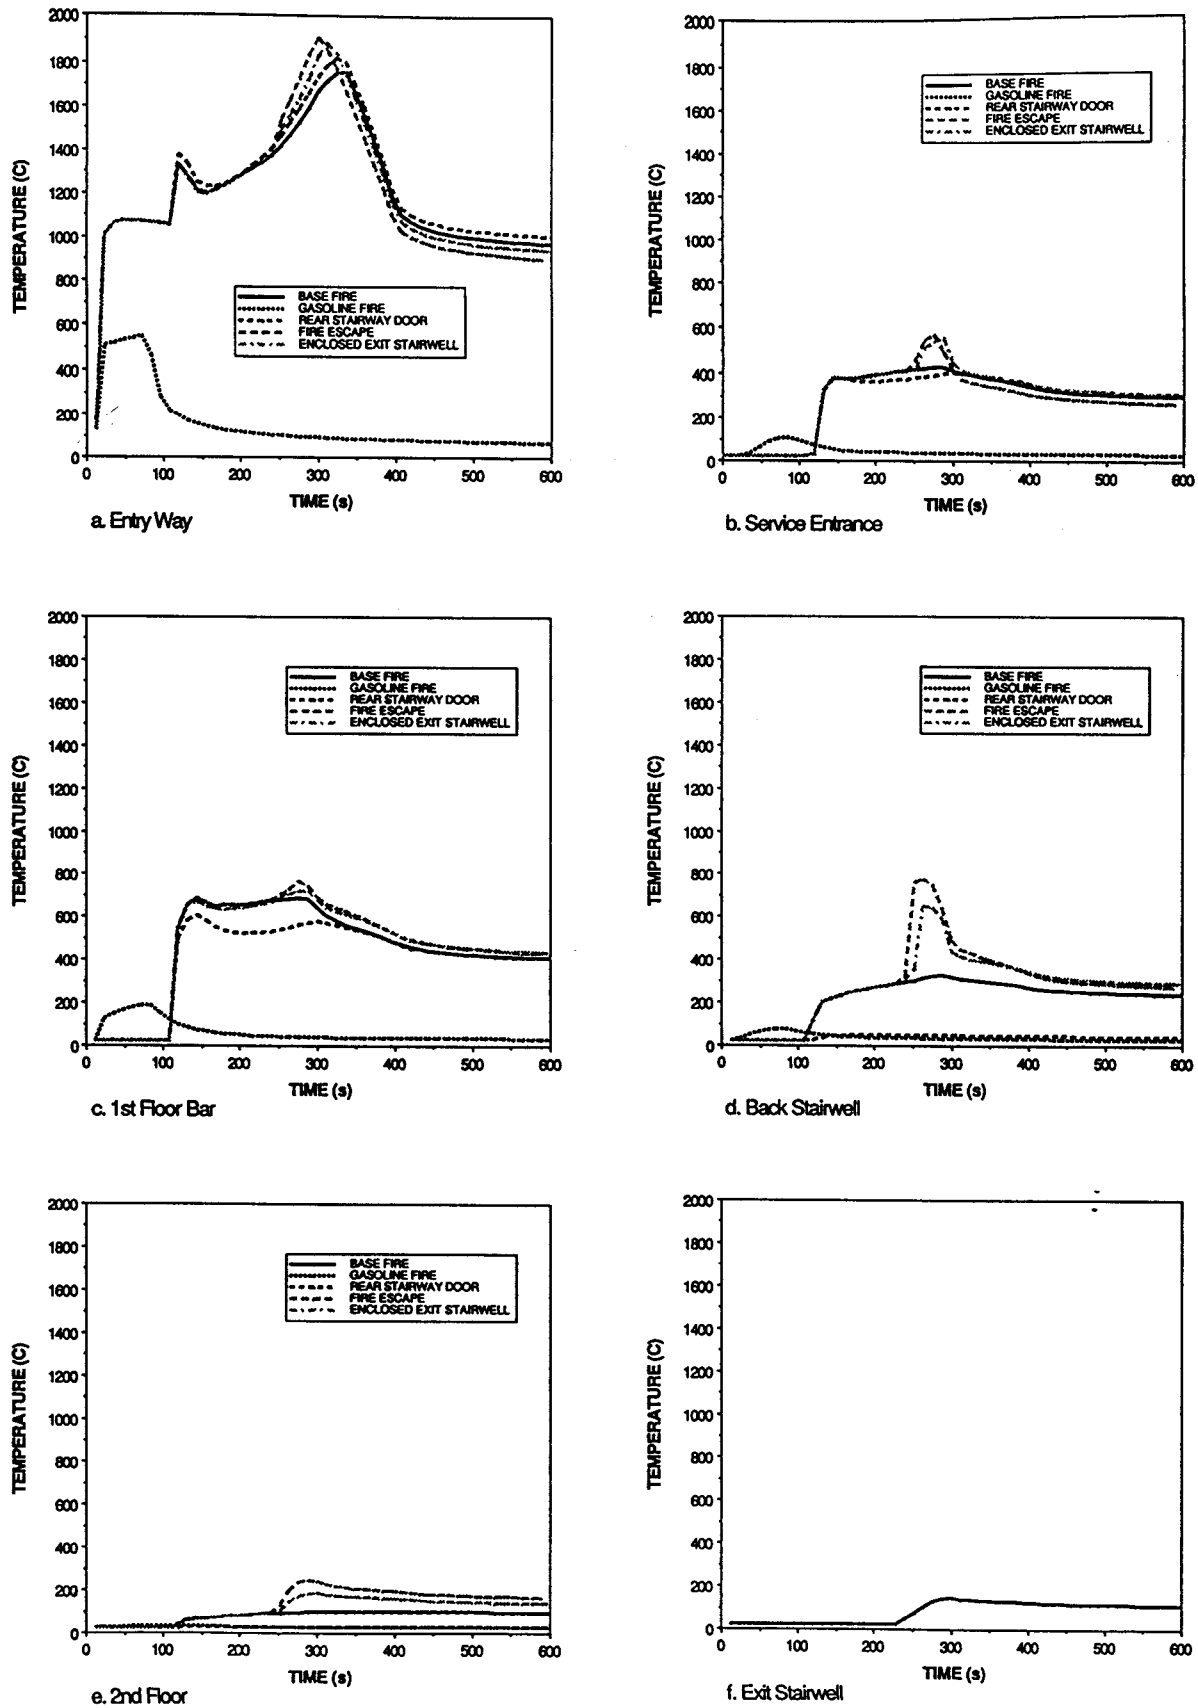
Figure 1. Predicted upper layer temperatures.

It should be noted that the peak upper layer temperatures shown in Figure 1a are too high. Such temperatures reported from experiments rarely exceed 1000°C. Zone models are known to overpredict upper layer temperatures and underpredict lower layer temperatures, because not all mechanisms of energy exchange between layers are included. FAST is no exception, with such overprediction having been estimated at 30–50% under most conditions and higher under severe conditions. Since these overpredictions occur after the times of death, they have little effect on hazard-to-life prediction.

To examine this strategy, a (closed) solid wood door at the first floor entry to the stair was assumed. An effective crack width of 1.3 cm (0.5 in) was assumed over the height of the door to represent the gap to the frame. The simulation run for these conditions showed a reduction in the predicted temperatures within the rear stairway and the second floor (Figure 1, d and e), as expected. The temperature of the first floor bar (Figure 1c) was also lower, as less flow up the stairs reduced the ventilation rate through the front door reducing the oxygen (Figure 4, a and c) and the burning rate (Figure 2, a and c) in both the entry and the bar. The CO levels upstairs (Figure 5e) were significantly lower, and the levels on the first floor (Figure 5c) were reduced due to the lower burning rate.

When the noncombustible finish scenario was run in HAZARD I, the results indicated that temperatures (Figure 1), CO (Figure 5), and oxygen concentrations (Figure 4) remained tolerable throughout the fire. Only a person in the entryway would have experienced lethal conditions, from burns. With both doors to the entryway open, the gasoline fire had sufficient air to burn out without producing flames out either door, so ignition of furniture in the bar would be unlikely. But if the fire had involved the contents of the bar (e.g., if the fire was started in the bar), some life loss would be likely, even with noncombustible finish.

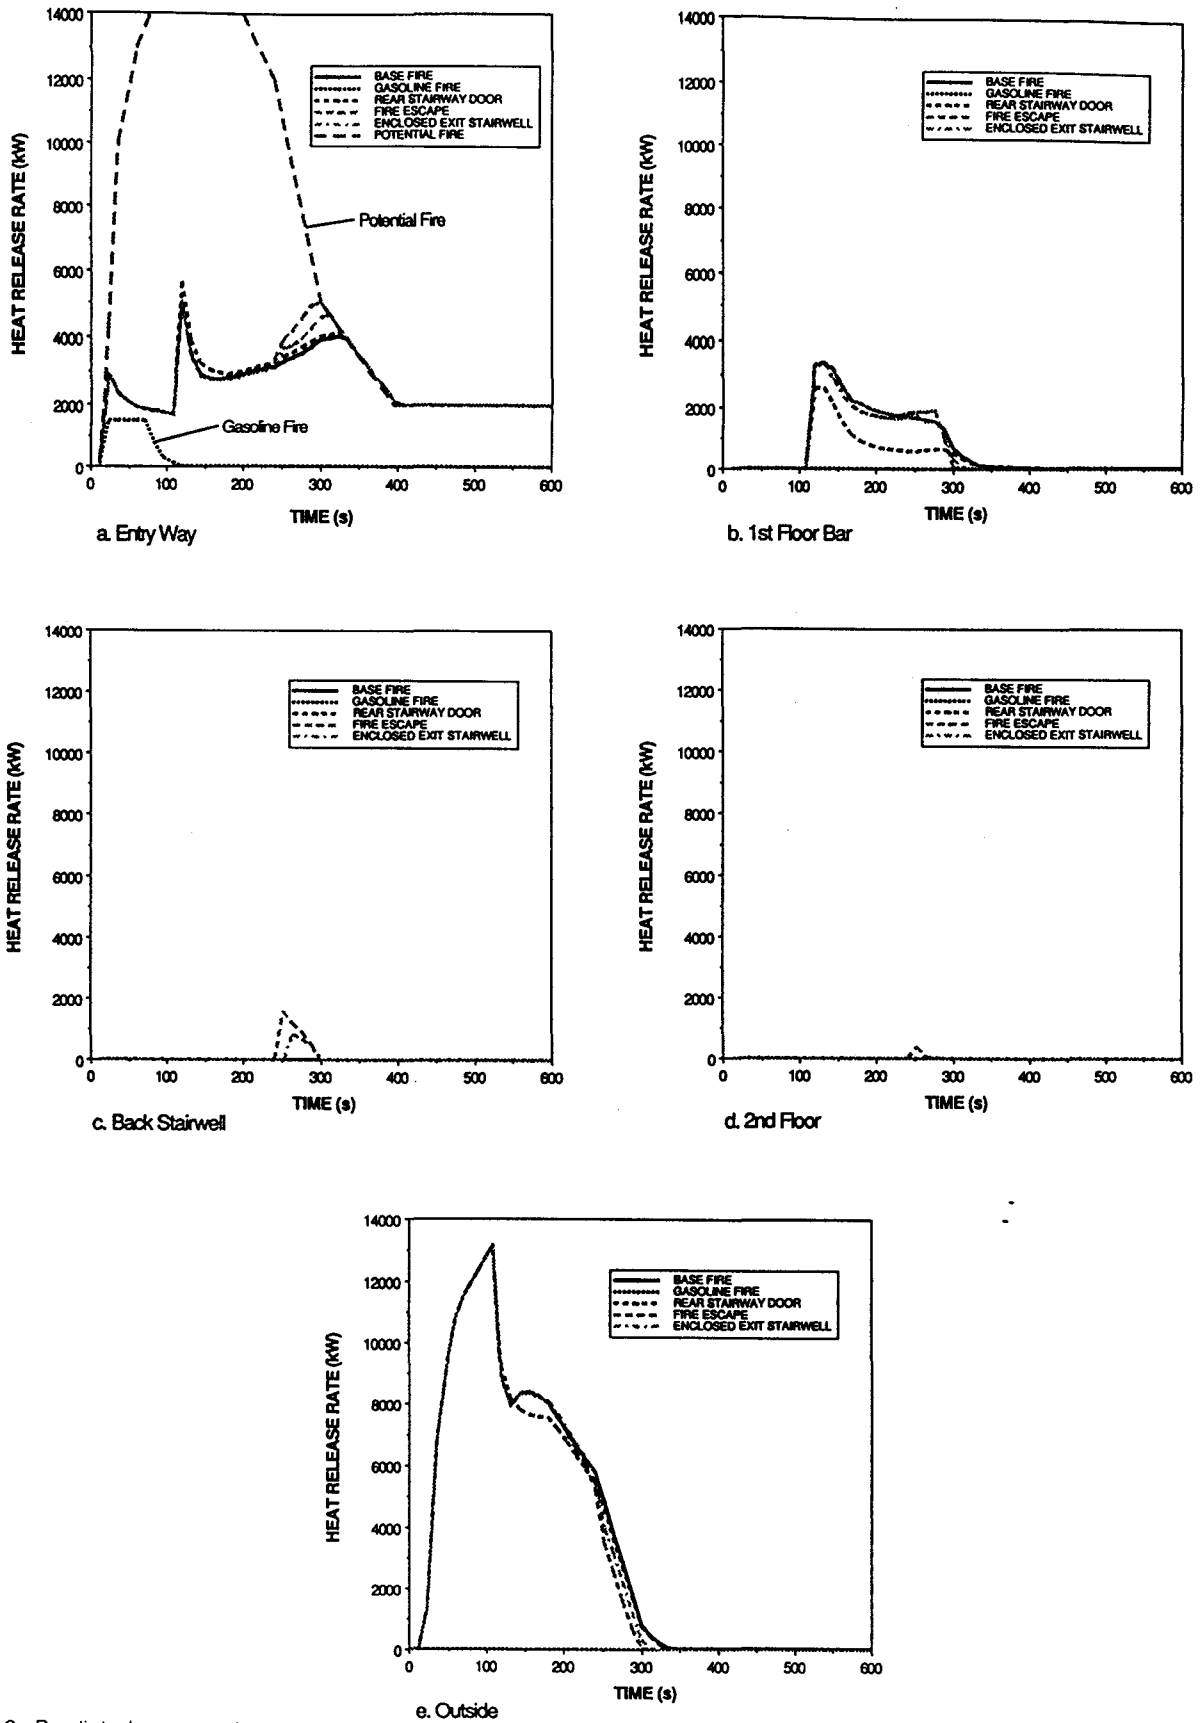
Figure 2. Predicted energy release rates.

procedures in the HAZARD I manual were used. The resulting potential energy release rate profile for the gasoline alone and in combination with the finish materials in the entryway are shown as "GASOLINE FIRE" and "TOTAL POTENTIAL FIRE" in Figure 2a. The difference between the potential rate of heat release and the rates of heat release predicted by HAZARD I for the cases analyzed (except the gasoline fire) results from the impact of the limited air supply. The rate of heat release estimated by HAZARD I for the case where the only combustible material was the gasoline is identical to the potential rate of heat release of the gasoline. This was because the available air supply was sufficient to freely burn all of the gasoline.

The predicted conditions within the building for the incident (labeled *base fire*) and for each mitigation strategy are presented in the Figures 2 through 5. Data for a single variable (e.g., temperature, oxygen concentration) are presented in each figure consisting of a graph for each room with a curve for each case examined. All graphs for a given variable use the same scale for easy comparisons.
