NBSIR 87-3640

Investigation of L'Ambiance Plaza Building Collapse in Bridgeport, Connecticut

Center for Building Technology
National Engineering Laboratory
National Bureau of Standards
Gaithersburg, MD 20899

Issued September 1987

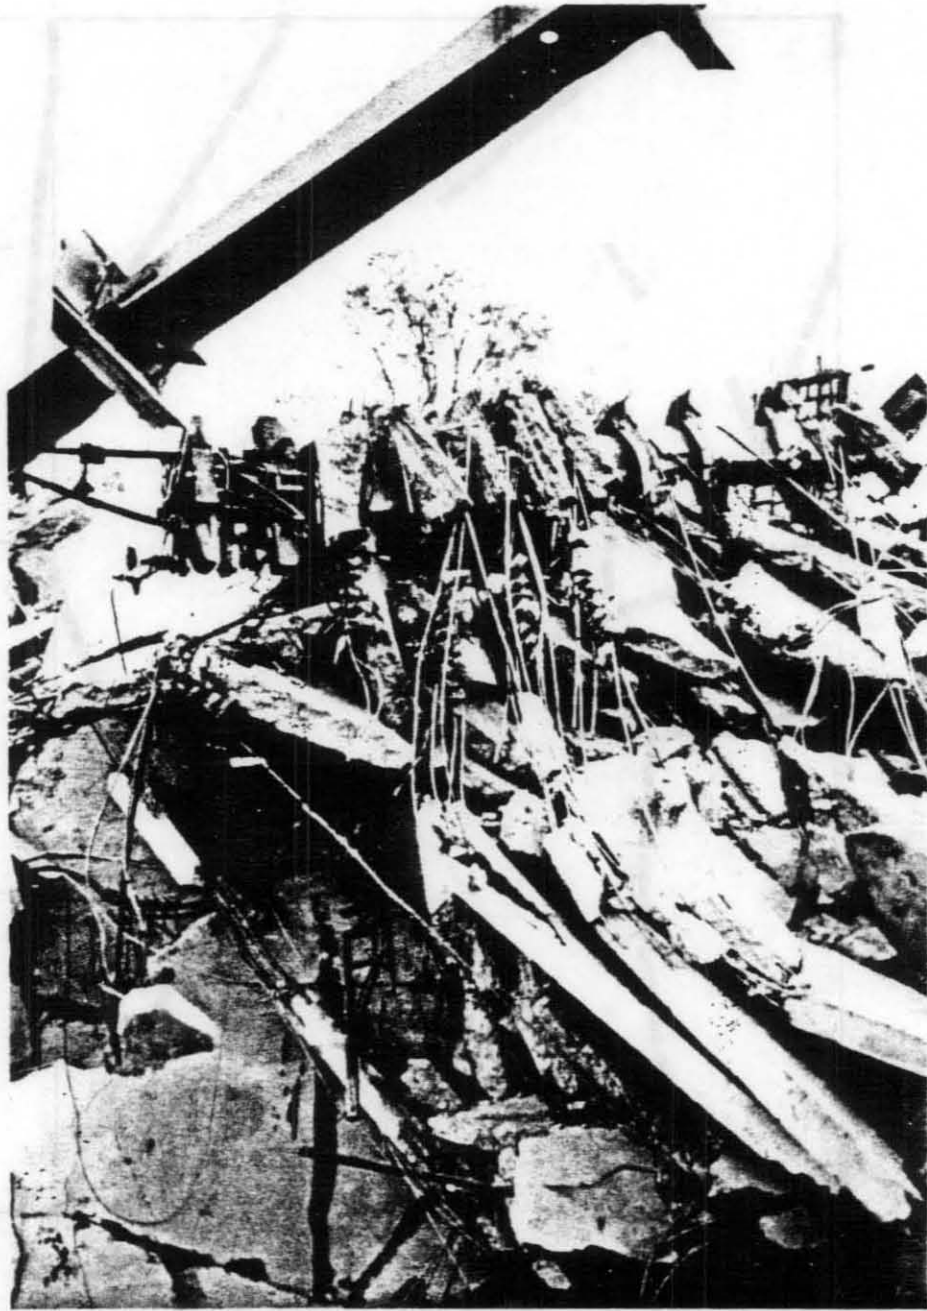
Figure 4.4.15 Separation of floor slabs from shearheads

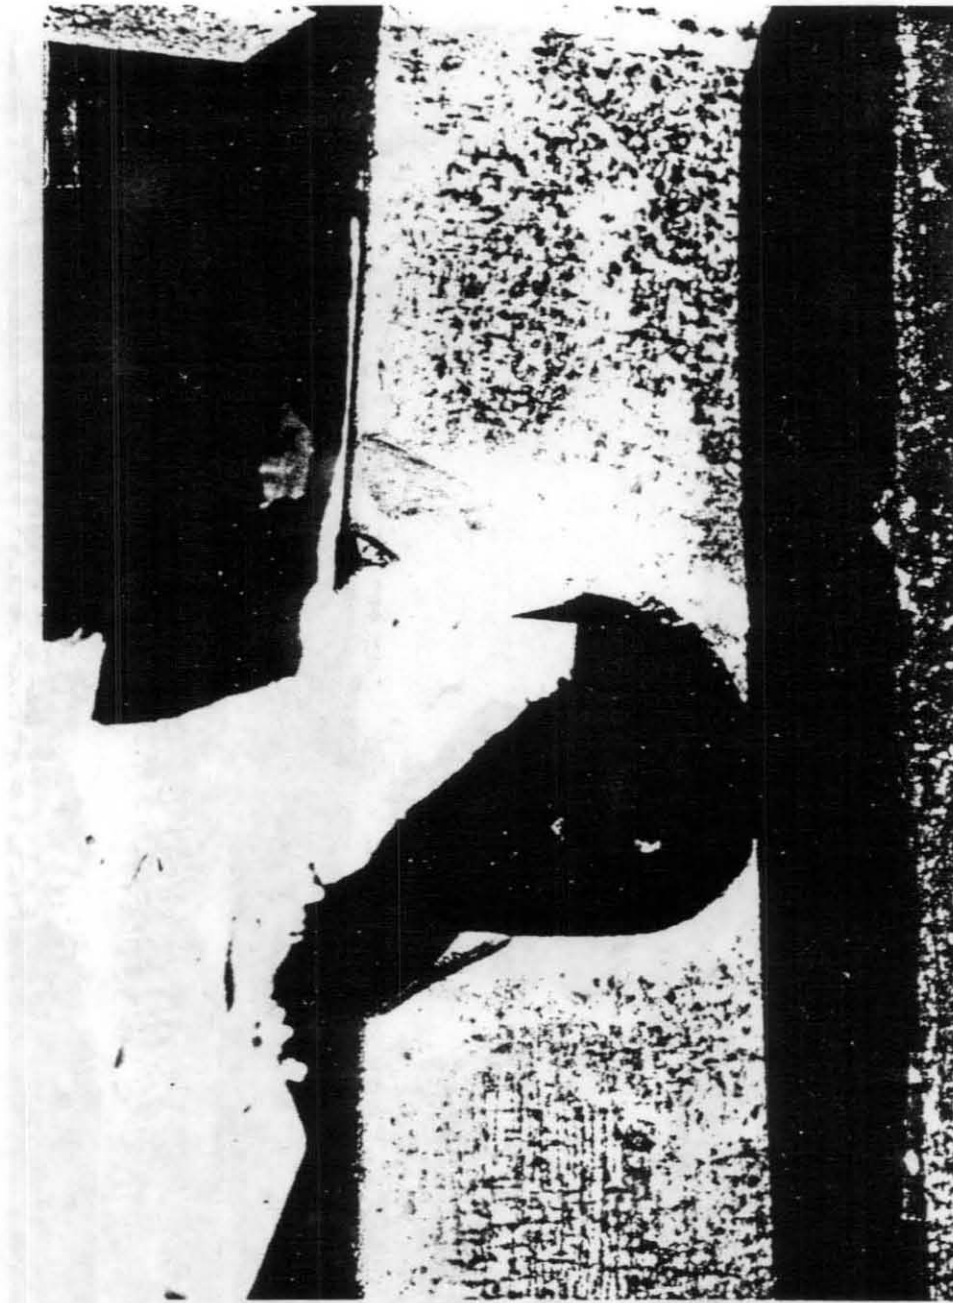
Figure 9.3.4 Indentation in underside of lifting angle, column E3.8, level 10

As has been noted in the discussion of test results in Section 5.5.5, a jack load of 190 kips (845 kN) acting on the type X51 shearheads of column E3.8 would produce very significant rotations of the lifting angles, possibly leading to kick out of one or both of the lifting nuts. The bottom surfaces of the lifting angles of the shearhead at slab 9, column E3.8, are shown in figure 9.3.3. The marks on these surfaces show that kick out did indeed occur. This sudden release of energy would be expected to raise dust from the surfaces of the concrete slabs and the noise associated with the kick out experienced in the lifting assembly tests described in Section 5.5.5 could readily be described as steel breaking under stress. This is consistent with the eyewitness accounts (#3 and #4 - figure 4.3.1). The surviving witness working at column E4.8 at the time of the collapse (#14 - figure 4.3.1) noted that the first indication of a problem was a loud noise either right above his head (E4.8) or more towards the center of the slab (E3.8). Due to load redistribution, loss of a jack at either E3.8 or E4.8 would lead to failure of the other jack. As floor slabs 9/10/11 moved downward, the shears and moments in the slabs adjusted to the new support conditions. Because the post-tensioning tendons now were located in the compression side of the slabs, the tendons adjacent to columns E3.8 and/or E4.8 became ineffective and flexural cracks developed in the bottom face of the slabs. This explains the sudden appearance of cracks in the slab directly above the workmen who were installing wedges at column E4.8. The underside of shearhead 10, column E3.8, is shown in figure 9.3.4 and that of shearhead 11 is shown in figure 9.3.5. It appears that one of the lifting nuts glanced off of the web and became partially lodged under shearhead 10. As the slabs moved downward due to loss of support at column E3.8, the lifting nut was again kicked out from under a lifting angle. The imprint on the underside of shearhead 11 suggests that this process was repeated for a third time. It was not possible to confirm this sequence of events with lifting nut impact points on the web because the top section of column E3.8 could not be positively identified. The likely progression of the collapse through the upper levels of the west tower is described in the following paragraphs.
